HISTORIC RESOURCES INVENTORY - BUILDING AND STRUCTURES

Building Name (Common) Olive Miller House

Street Address or Location 29 Route 107 (previously 27 Redding Road, lot subdivided in 2014)

29 Route 107, Wilton

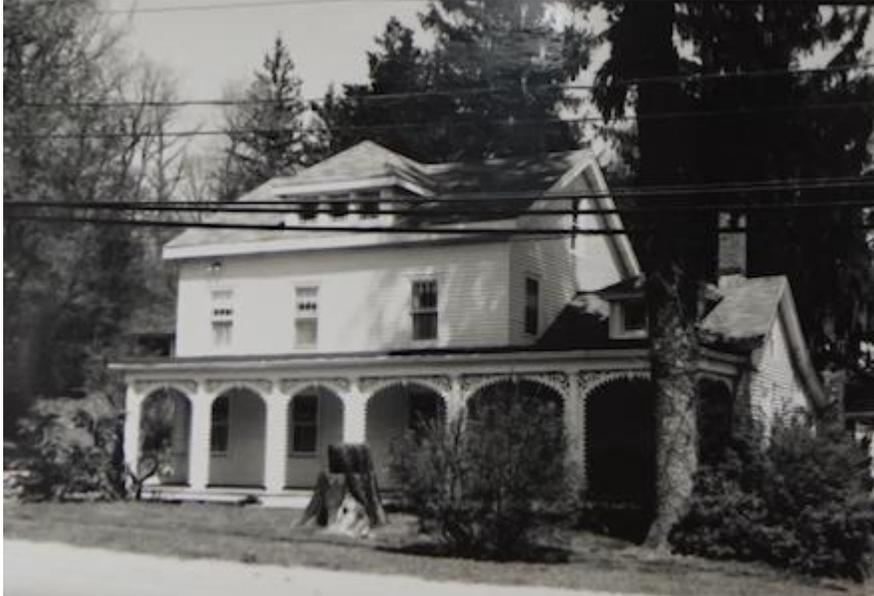
Photograph 27 Route 107 View South

Local tradition holds that the two-section house incorporates an earlier structure, but the physical evidence offered by the structure itself suggests that it dates to the first decade of this century. The main mass is a three-bay, two-story, gable-roofed pile with no entrance bay and a full-façade, Tuscan-columned verandah. The milled trim is recent. The overhanging eaves are boxed, and lozenge-patterned sash-over-one windows are used on the façade. Flashed windows are used in the squat, hipped dormer, the gable ends, and the one and one-half-story ell. The house is well pre-served.
