## HISTORIC RESOURCES INVENTORY - BUILDING AND STRUCTURES

Building Name (Common) United Methodist Church of Georgetown.

Street Address or Location 37 Church Street 12/93

**37 Church Street, Wilton**

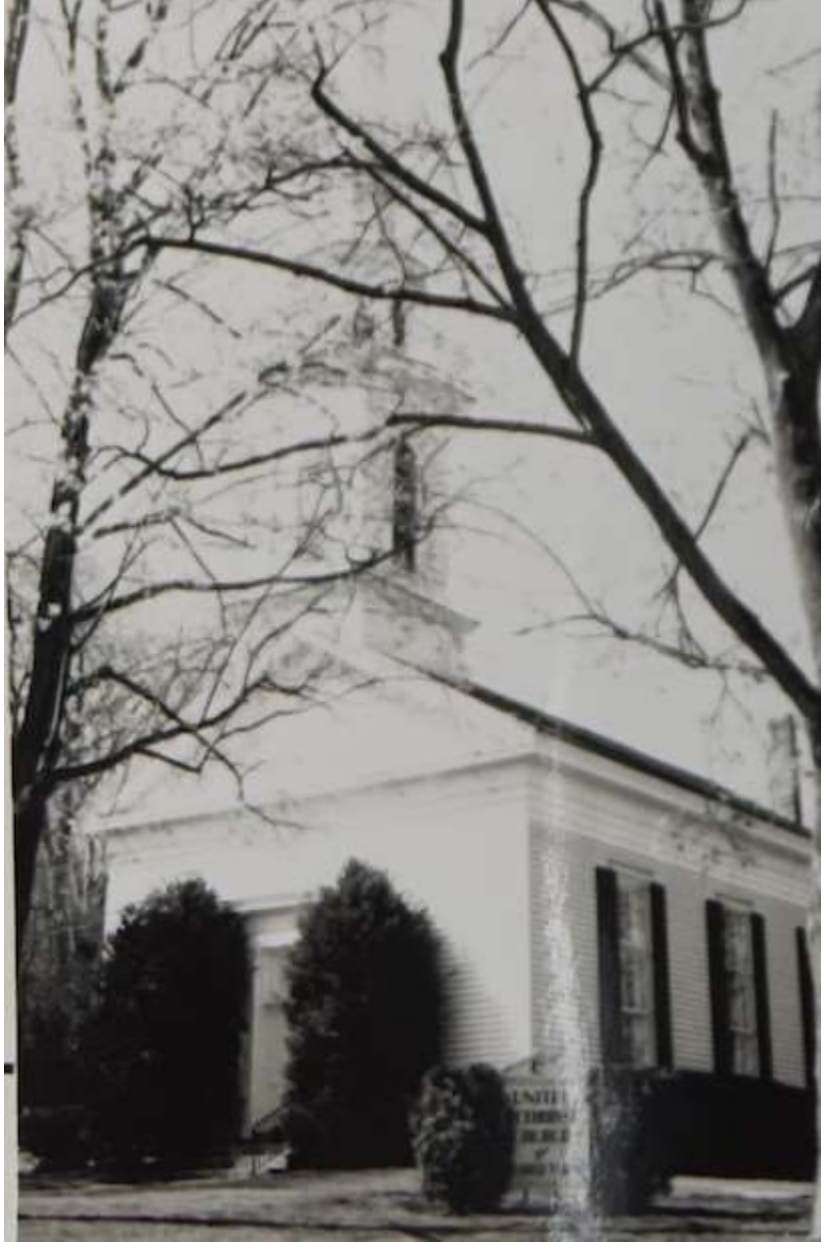
Photograph 37 Church Street. View northeast.
