HISTORIC RESOURCES INVENTORY - BUILDING AND STRUCTURES

Building Name (Common) Deacon Daniel Gregory House
Building Name (Historic) Same
Street Address or Location 11 Belden Hill Road
Town/City Wilton Village _____ County Fairfield
Owner(s) Jerre & Thomas Dawson ☐ Public ☒ Private

11 Belden Hill Road, Wilton

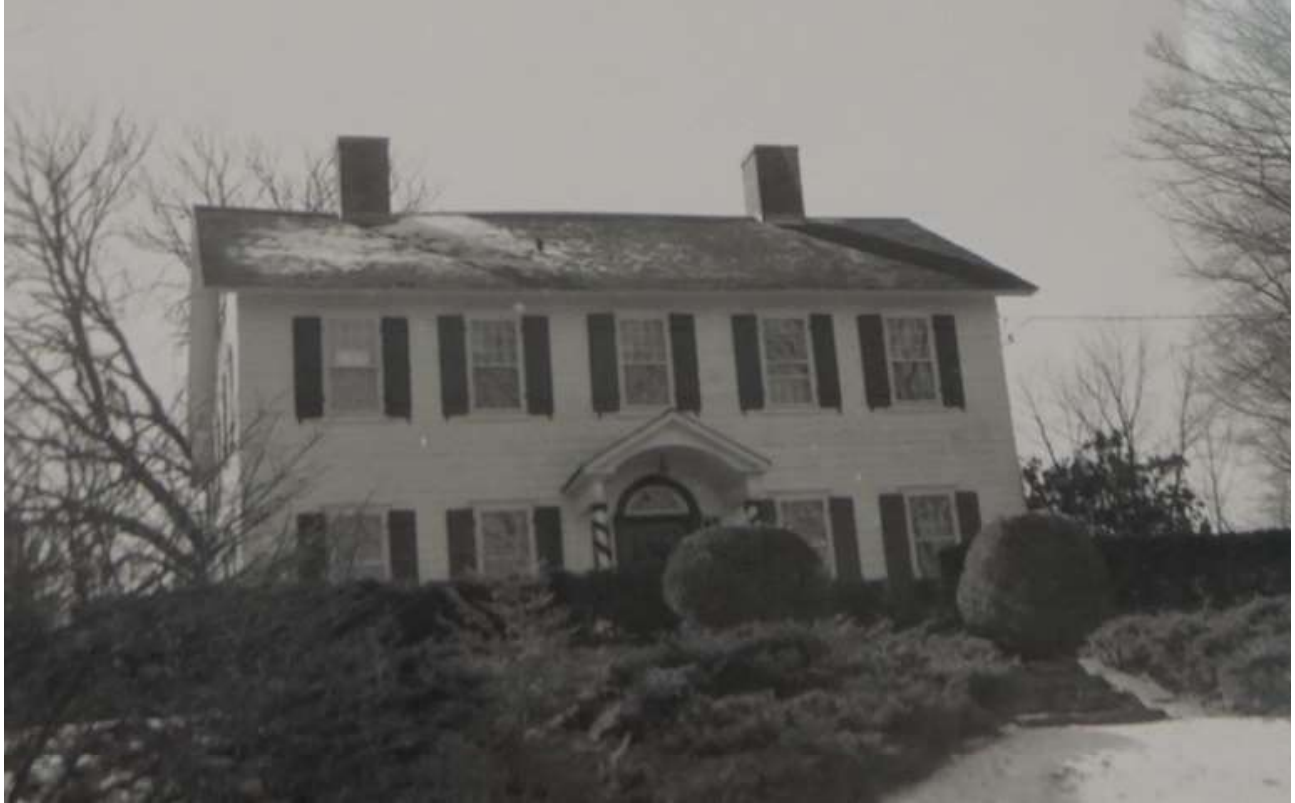
Photograph 11 Belden Hill Road. View east.

The handsome Colonial/Colonial Revival house with six-over-six windows is dramatically sited on a rise overlooking Wilton Center and is surrounded by generous, casually landscaped grounds. The house, with two interior end chimneys, apparently never had a central chimney, but its exterior is more Colonial Revival than period. It was extensively "improved" during the 19th century with the addition of milled trim, a full-façade verandah, bay windows, and a roof with boxed overhanging eaves. The house passed out of the original family in 1932 and it was reworked in the prevailing Colonial Revival taste. All Victorian-era additions, save the roof, were removed and replaced by superbly executed, Federal-inspired trim, including the handsome, well proportioned, arched soffit, entrance portico with Doric colonettes and entablature with mutules. The six-panel door is topped by an elliptical transom and is flanked by operable side sash. The rear two-story ell is also Colonial
