HISTORIC RESOURCES INVENTORY - BUILDING AND STRUCTURES

1 Church Street, Wilton

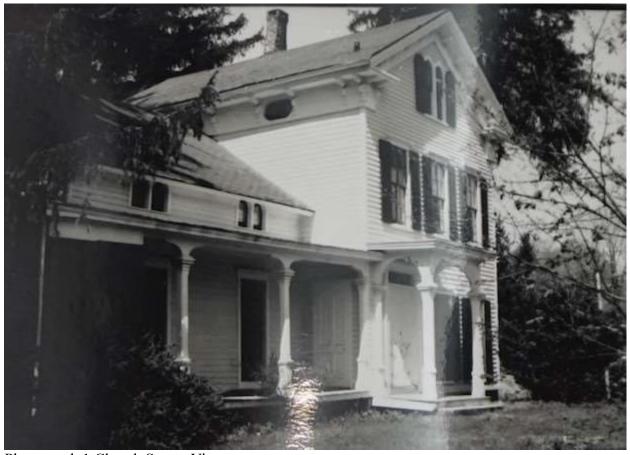
Photograph 1 Church Street. View east.

The superbly detailed and well-preserved Italianate house has a three-bay, gable-ended section with a recessed, one-and-one-half-story gabled ell to the south. The main block has bracketed overhanging eaves and a cornice return on the gable end. The frieze is pierced by oval frieze windows, and the gable end is filled with a coupled, circular-headed window. It is not certain if the veranda originally extended across the entire front of the house, but its present configuration with an arched frieze porch at the entrance appears to be correct. It is set with chamfered, Italianate posts. Double-leaf doors with a small transom above fill the offset entrance bay. The ell is sheltered by a full-length veranda of corresponding styling, and its gable end has a Gothic barge

board. Full-length windows are used on the first level and four-over-four sash fill the upper level and second elevations. A 19th century barn survives to the rear of the house and a new barn/workshop is located to the south of the house. The property contributes greatly to the historic character of Georgetown.
