HISTORIC RESOURCES INVENTORY - BUILDING AND STRUCTURES

Building Name (Common) Georgetown Methodist Church Parsonage
Building Name (Historic) Parsonage
Street Address or Location 33 Church Street 12/92
Town/City Wilton Village _____ County Fairfield
Owner(s) United Methodist Church ☐ Public ☒ Private

33 Church Street, Wilton

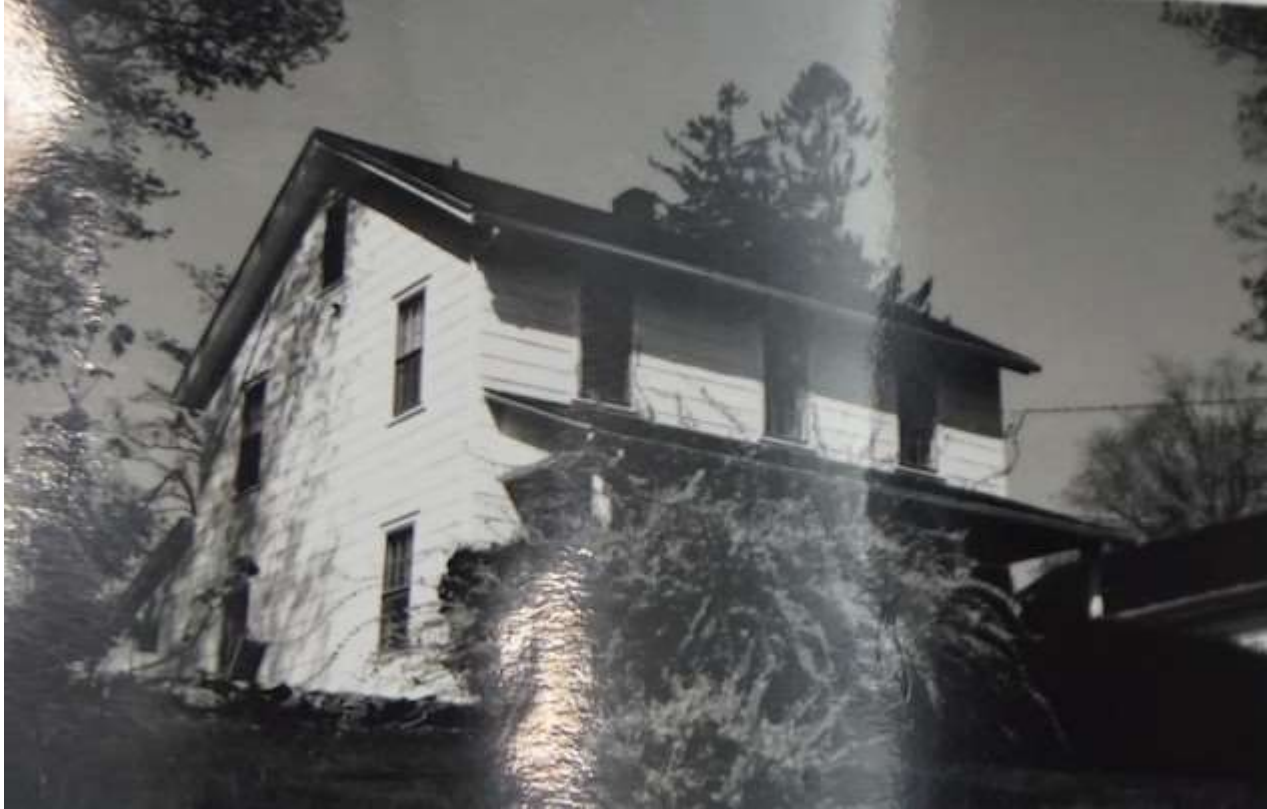
Photograph 33 Church Street. View southeast.

The simple, three-bay, two-story, central hall plan dwelling built circa 1875 has boxed, overhanging eaves and six-over-six windows. The façade is sheltered by a shed roof veranda with chamfered, Italianate posts with molded caps, and the entrance door has glazed, circular-headed upper panels. A lean-to addition extends the rear elevation. Asbestos shingles hide the original sheathing, but otherwise the house appears to be well preserved.
