## HISTORIC RESOURCES INVENTORY - BUILDING AND STRUCTURES

Building Name (Common) Wilton Railroad Station  
Building Name (Historic) same  
Street Address or Location 146 Danbury Road  
Town/City Wilton Village \_\_\_\_\_ County Fairfield  
Owner(s) Wilton Historical Society ☐ Public ☒ Private

**146 Danbury Road, Wilton**

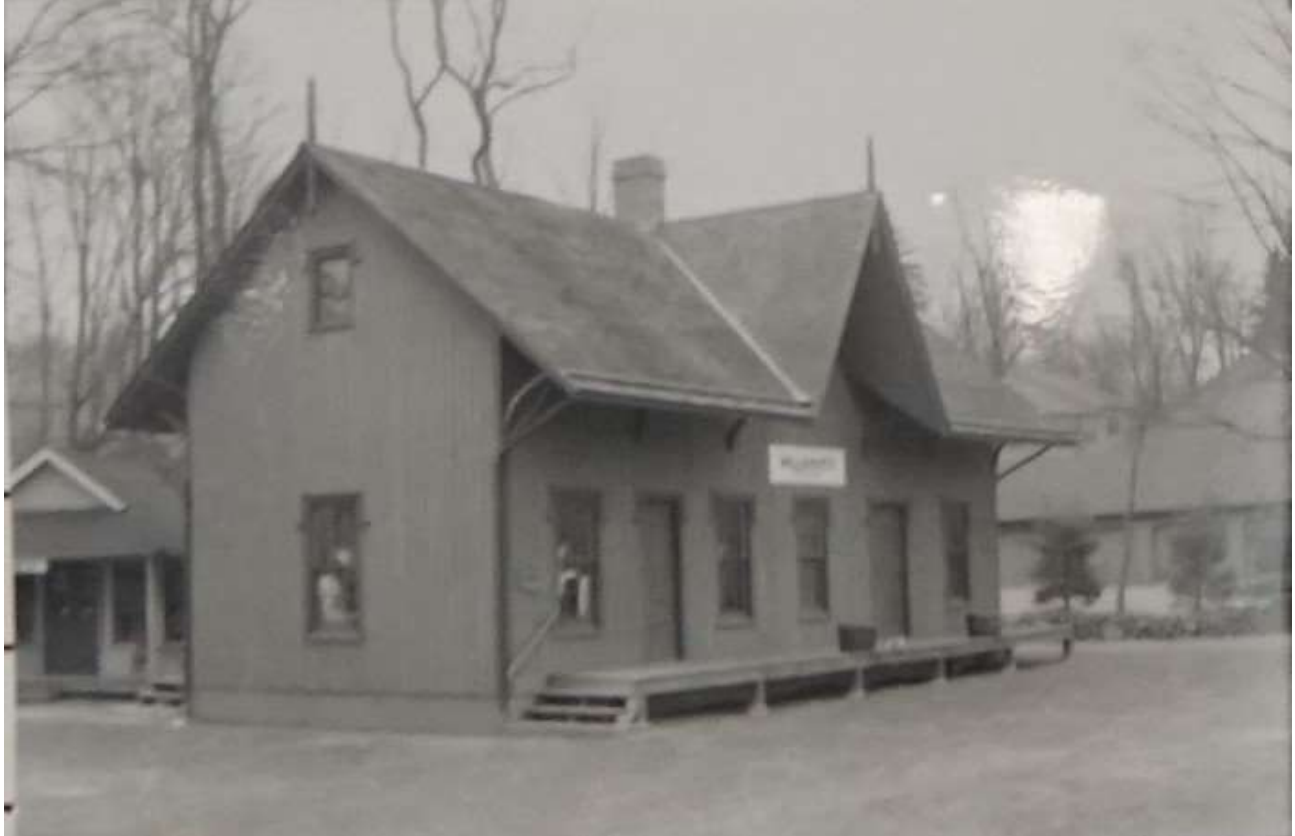
Photograph 146 Danbury Road. View northwest.

The board-and-batten sided, gable-roofed structure with cross gables on both elevations was dismantled and moved to the present site in 1978 and restored to its original appearance. Built in 1852, it was remodeled in 1892. The overhanging eaves are set with brackets and the six-over-six windows have drip moldings. The waiting room portion of the building was finished but the freight house, serviced by diagonally paneled doors was originally left with the framing exposed. The paint scheme is based on physical evidence of the original. Most of the fabric dates to 1978 as the building was severely deteriorated before it was moved.
