## HISTORIC RESOURCES INVENTORY - BUILDING AND STRUCTURES

Building Name (Common) Hurlbutt Street Post Office and General Store

Street Address or Location 150 Danbury Road

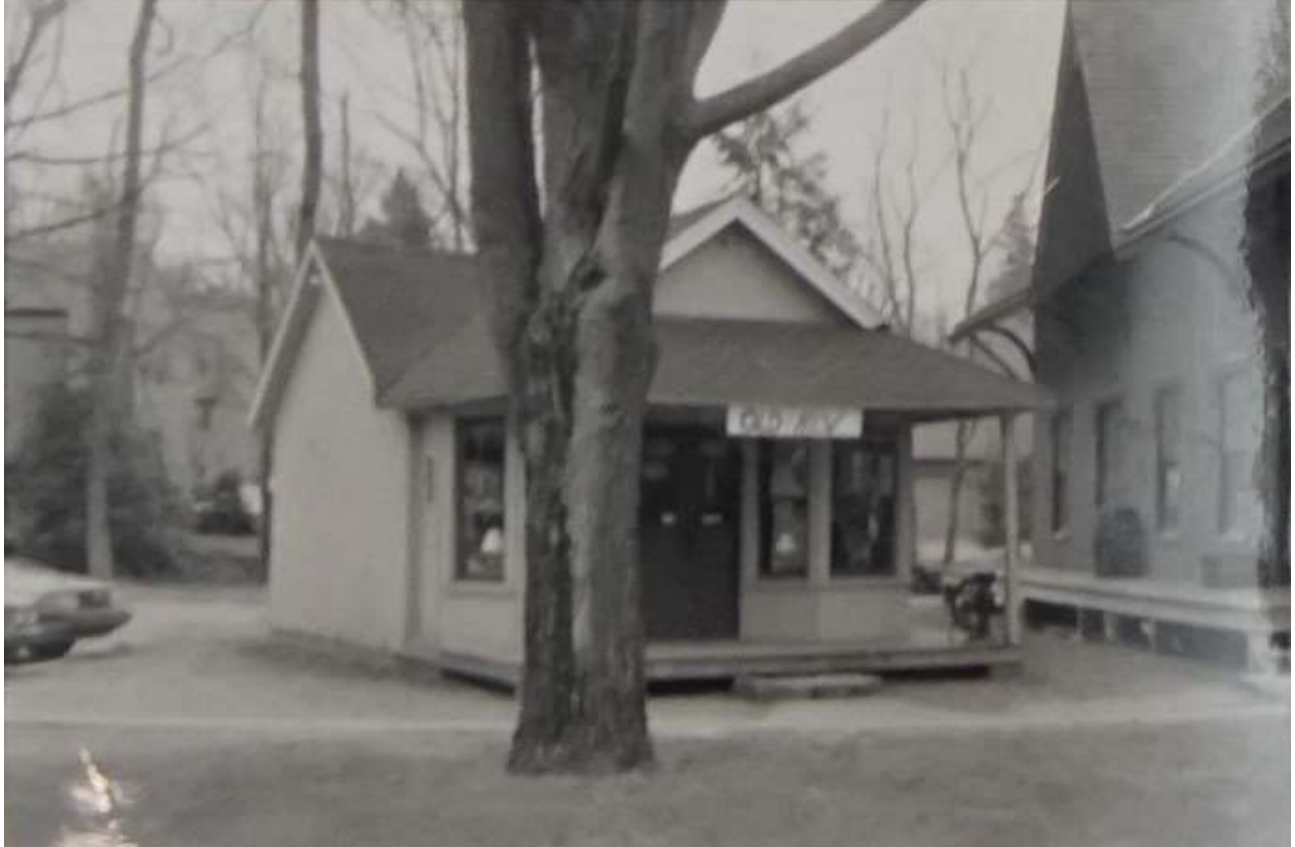
Photograph 150 Danbury Road. View northwest.

The small, three-bay, frame grocery store has a central gable front section sheltered by a simple, shed-roofed porch with plain posts. The façade is opened by octagonal-ended bay, showcase windows flanking the paneled, double-leaf doors with glazed upper panels. The interior is finished with cottage board. None of the original counters or shelving survives, but the exterior is remarkably complete.
