HISTORIC RESOURCES INVENTORY - BUILDING AND STRUCTURES

Building Name (Common) Kent District School
Building Name (Historic) same
Street Address or Location 150 Danbury Road
Town/City Wilton Village _____ County Fairfield
Owner(s) Wilton Historical Society ☐ Public ☒ Private

150 Danbury Road, Wilton

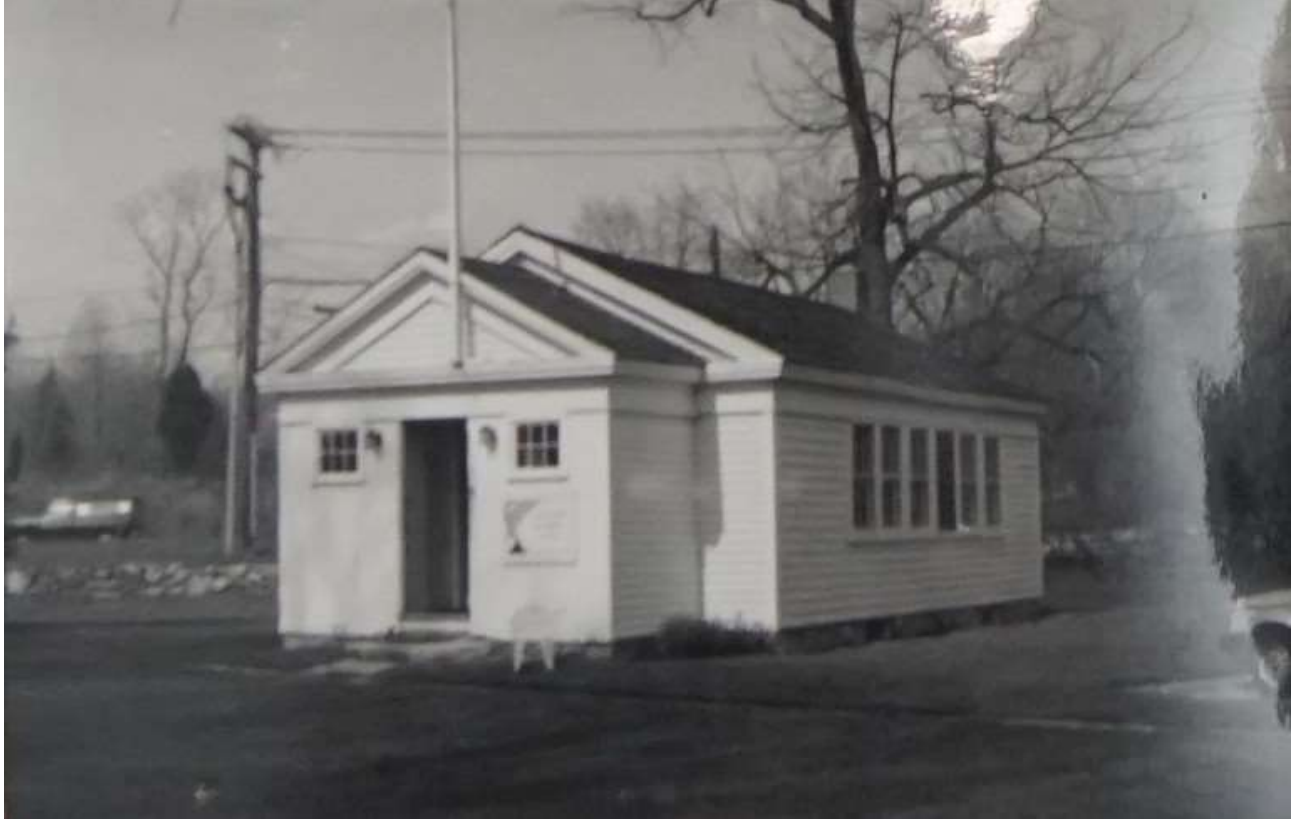
Photograph 150 Danbury Road. View southwest.

Of the six extant district schoolhouses in Wilton, the Kent School is the second oldest. The gable-ended structure with a smaller, echoing vestibule, is finished with a continuous entablature that returns on the gable ends. Ranges of large, six-over-six windows open the side elevations, and the stove flue survives on the rear elevation. The sides of the entrance vestibule are sheathed in clapboards to match the body of the building, but the front is covered with what appear to be replacement flush boards. The interior of the one-room school has a barrel-vaulted ceiling that is believed to be original. The building is very well preserved.
