HISTORIC RESOURCES INVENTORY - BUILDING AND STRUCTURES

Building Name (Common) Lambert House
Building Name (Historic) Lambert House
Street Address or Location 150 Danbury Road
Town/City Wilton Village _____ County Fairfield
Owner(s) Wilton Historical Society, Inc. ☐ Public ☒ Private

150 Danbury Road, Wilton

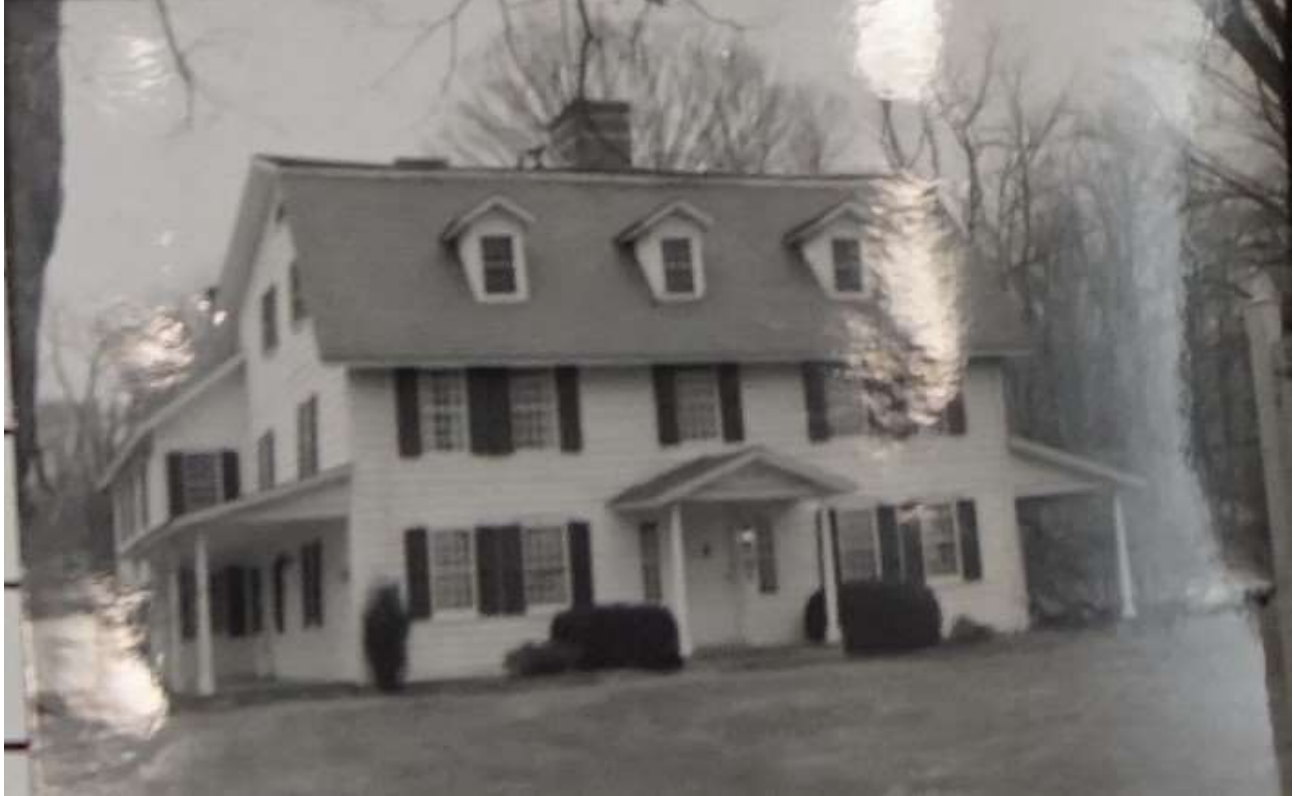
Photograph 150 Danbury Road – Lambert House. View west.

Few houses in Wilton are as architecturally curious as the large, five-bay, two-story, central chimney dwelling that was reworked in the Federal style. Local tradition holds that the house was built in 1724, but the height of the ceilings and spacing of the fenestration suggests that the house dates to the last quarter of the 18th century. There is no evidence to suggest that the house incorporates an earlier cape. The central chimney is set on a massive stone base that is larger than the chimneys themselves and it is also set with the steps to the basement. The massive framing members are exposed in the northern chamber on the second level, but the members on the first level have either been enclosed in the walls in the north chamber and boxed in the south chamber. Twelve-over-twelve windows are used throughout the original portion of the house, and they appear to be original, a significant feature. The central entrance is sheltered by a pedimented Tuscan-columned porch that is matched by side verandas, also with Tuscan columns. The side

porches are among the earlier in the region. The floor itself is six-panel and it is surrounded by a frontispiece with Federal moldings. The same frontispiece is used on the north door. The interior is arranged on the traditional, five-room plan, and most of the woodwork is original or added ca. 1810. The earlier addition is the kitchen wing to the south, and in 1828, the corresponding north wing was added. The gambrel roof with gabled dormers was added ca. 1880 when the house was used as an academy. The garage wing was added in the 1940s.
