## HISTORIC RESOURCES INVENTORY - BUILDING AND STRUCTURES

Building Name (Common) Johnson Houses  
Building Name (Historic) Ericson Houses  
Street Address or Location 5, 9 New Street 11/29, 30  
Town/City Wilton Village \_\_\_\_\_ County Fairfield  
Owner(s) \_\_\_\_\_ ☐ Public ☒ Private

**5 and 9 New Street, Wilton**

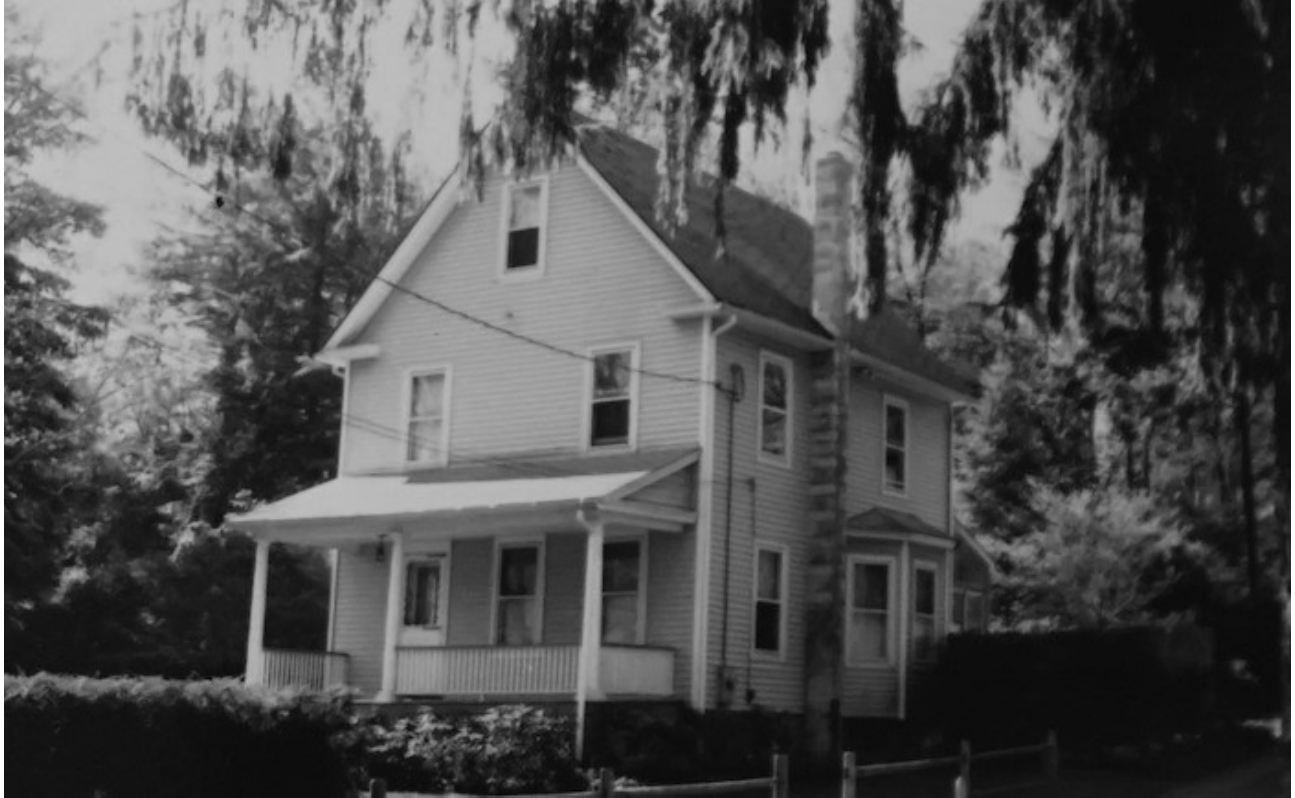
Photograph 5, 9 New Street. View northwest.

The pair of nearly identical, gable-ended, 3-bay, vernacular dwellings was constructed in 1913. A shallow cornice return accents the façade, and 1-over-1 windows are used throughout, including the gable ends. A once-story bay window opens the west elevation, and each has a full-façade verandah with Tuscan columns. The interiors are arranged on a four-room plan.
