## HISTORIC RESOURCES INVENTORY - BUILDING AND STRUCTURES

Building Name (Common) Davenport House  
Building Name (Historic) Deodate DavenportHouse  
Street Address or Location 108 Ridgefield Road  
Town/City Wilton Village \_\_\_\_\_ County Fairfield  
Owner(s) Finnie, Linda W. ☐ Public ☒ Private

### CONTINUATION SHEET 108 Ridgefield Road, Wilton

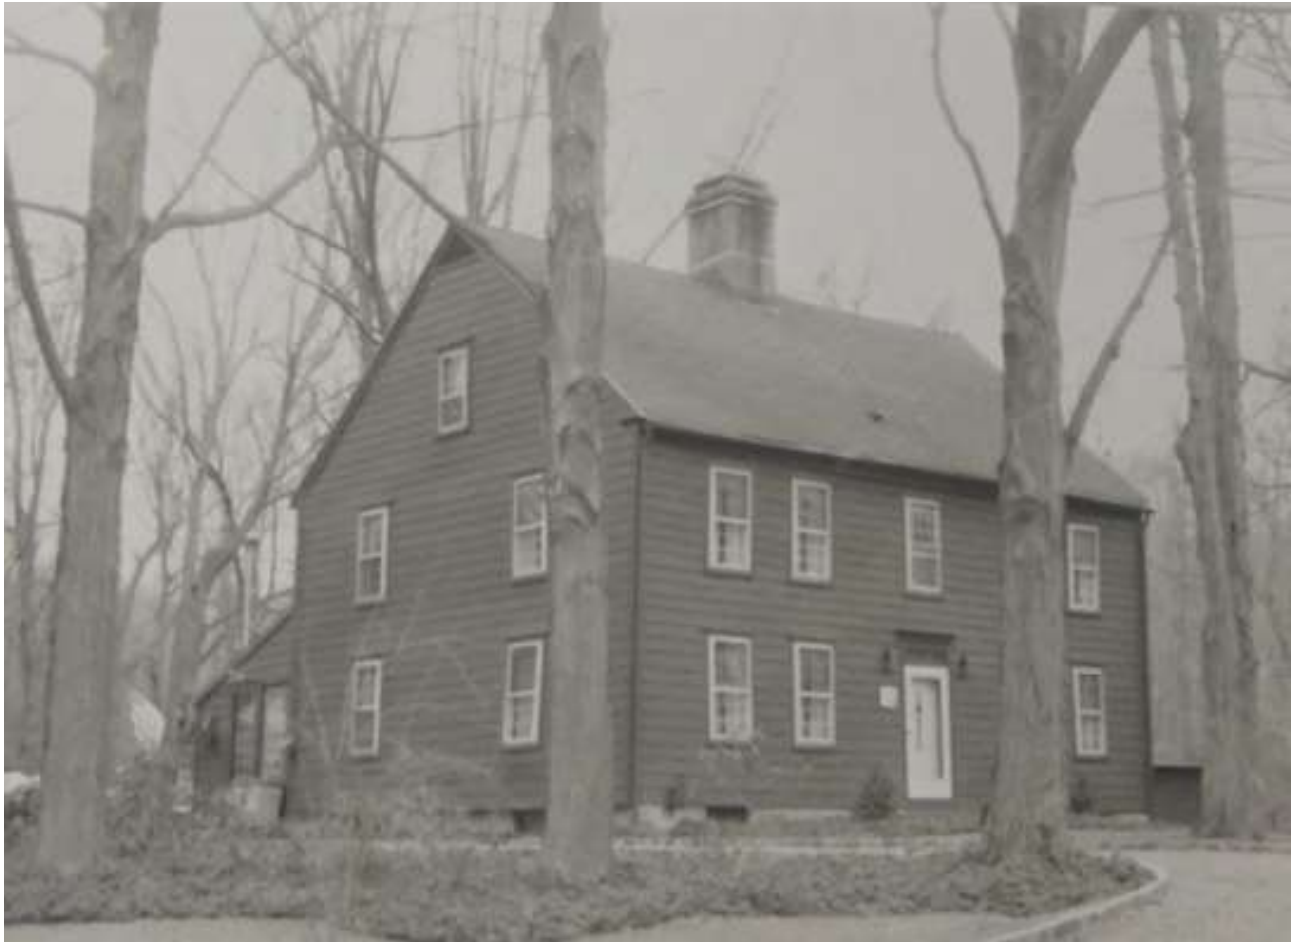
Photograph 108 Ridgefield Road View Southwest

The house is oriented to the south rather than the road.

The handsome and well proportioned, five-bay, central chimney dwelling is an excellent example of late 18<sup>th</sup> century domestic architecture. More generously proportioned and finished with larger window openings than earlier houses, it perpetuates the central chimney, five-room plan and the flush eave detail that dominated the century. Twelve-over-twelve windows are used throughout and the central entrance is accented by a Colonial Revival frontispiece with a denticulated cornice which has also been added to the façade eave. The house is oriented to the south rather than the

road, a common 18<sup>th</sup> century custom, and has a lean-to addition on the rear. It is not known if the house was remodeled in the 19<sup>th</sup> century, but if it was, all evidence of picturesque improvements have been removed. The house, now shingled, was originally clapboarded.
