HISTORIC RESOURCES INVENTORY - BUILDING AND STRUCTURES

Building Name (Common) Congregational Church Parsonage
Building Name (Historic) Congregational Church Parsonage
Street Address or Location 65 Ridgefield Road
Town/City Wilton Village _____ County Fairfield
Owner(s) Wilton Congregational Church, Inc. ☐ Public ☒ Private

CONTINUATION SHEET 65 Ridgefield Road, Wilton

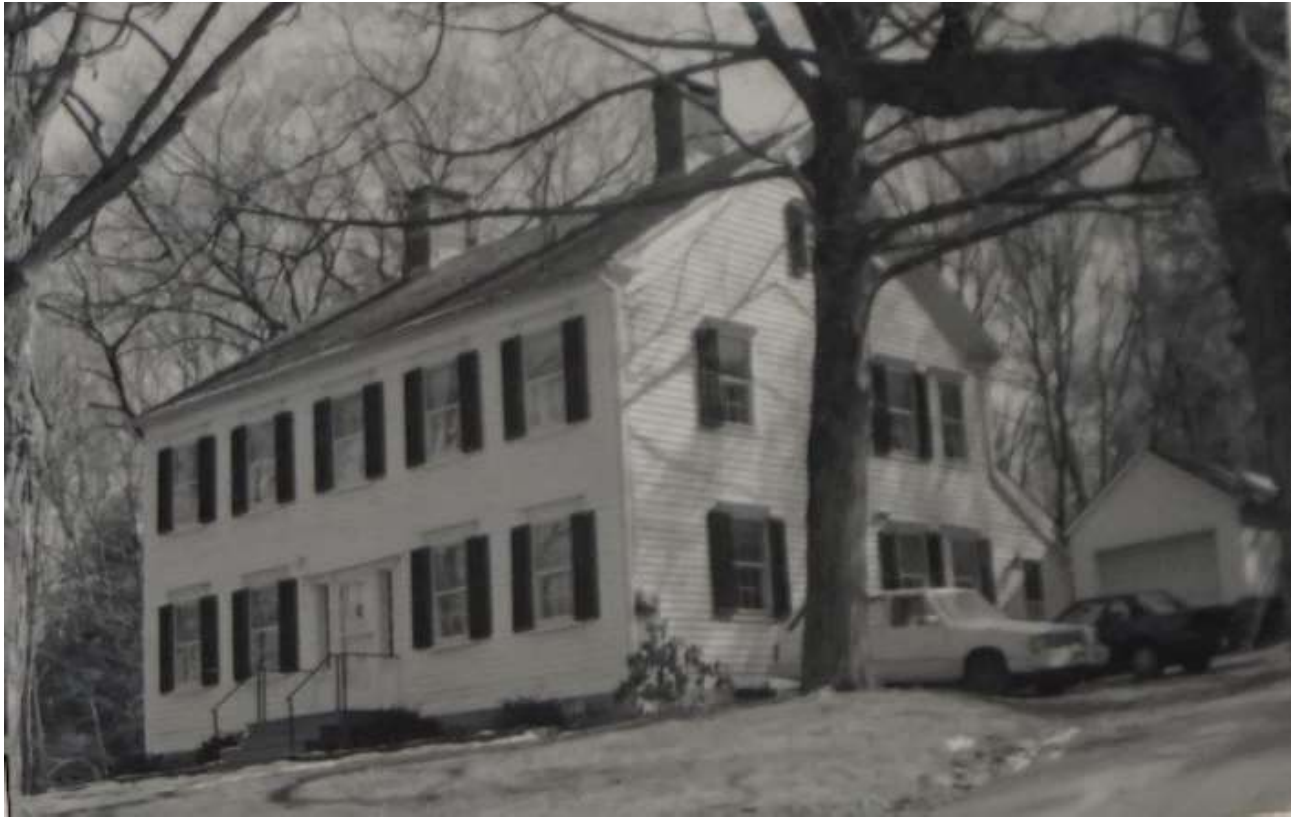
Photograph 65 Ridgefield Road View Northwest

The well-proportioned, five-bay, central hall dwelling with interior end chimneys (one of the few examples of such in Wilton) was built in 1832, and it stands in a remarkably complete state of preservation. Six-over-six windows with molded backbands on the architraves and molded caps are used throughout. The eaves are detailed with a frieze board that continues along the rake of the roof and a cornice return with Grecian molding profiles on the gable end. A pilastered frontispiece with transitional moldings accents the central entrance flanked by side lights. Historic photographs show that at the turn of the century the house had a handsome Italianate

verandah (non-extant) and was painted dark, Victorian hues. The lean-to ell on the rear appears to be a very early addition.
