HISTORIC RESOURCES INVENTORY - BUILDING AND STRUCTURES

Building Name (Common) Dana Parsonage
Building Name (Historic) Nathan Comstock House
Street Address or Location 77 Ridgefield Road
Town/City Wilton Village _____ County Fairfield
Owner(s) Wilton Congregational Church, Inc. ☐ Public ☒ Private

CONTINUATION SHEET
77 Ridgefield Road, Wilton

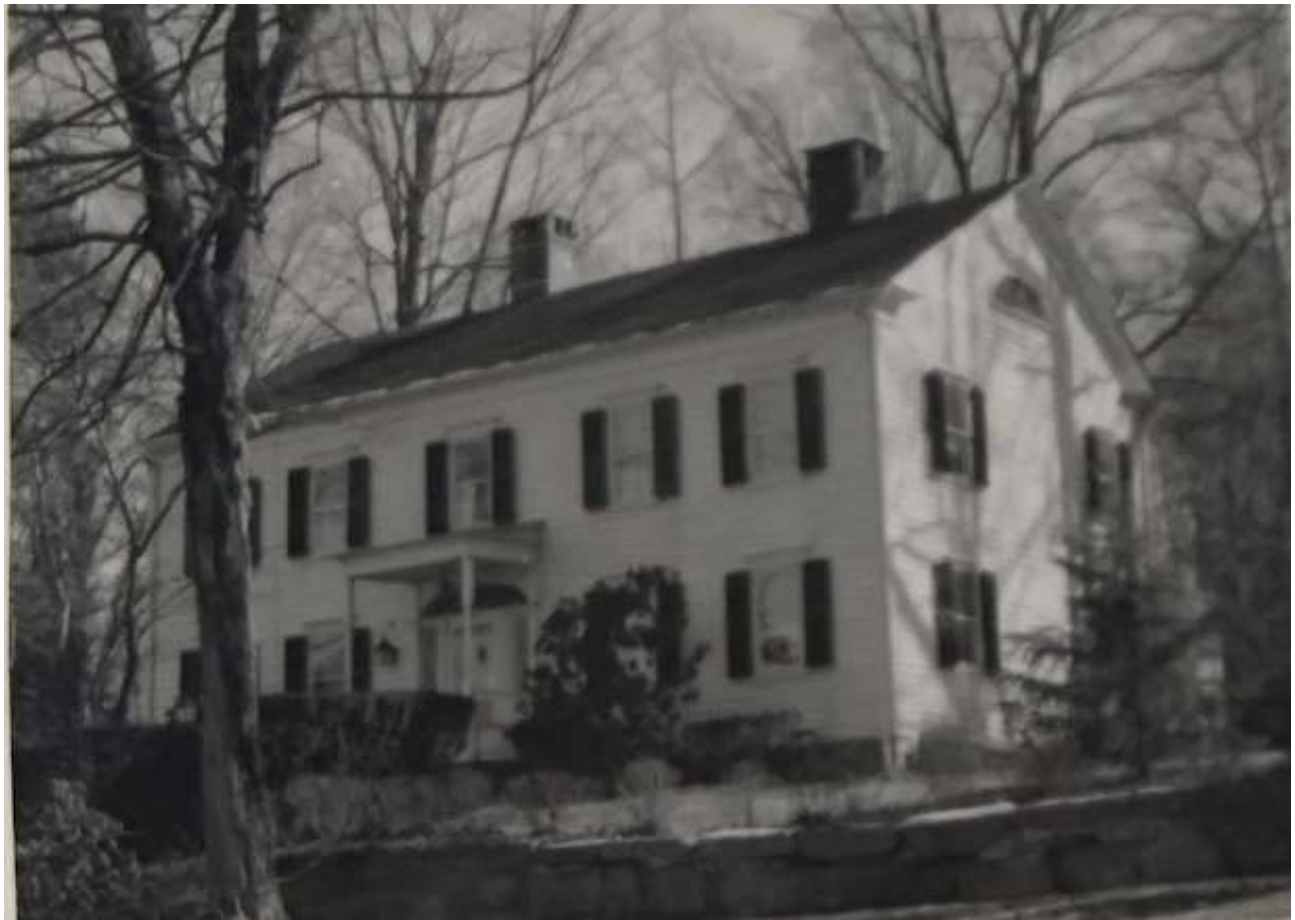
Photograph 77 Ridgefield Road View Northwest

The five-bay, two-story, Federal dwelling was built in two sections. Breaks in the entablature as well as evidence of the original exterior wall on the west side of the stairway conclusively prove that fact. The original house, the easternmost three-bays, is arranged on the typical four-room plan with the kitchen fireplace in the back room. The westernmost file of rooms was added shortly after the house was completed, and the woodwork throughout is transitional, but it is more Federal than Greek and is of the highest quality. High base boards are used throughout and the window and door architraves are built up. Of particular significance is the superbly detailed entrance bay with an elliptical transom and side lights with the doorframe are reede. The supports carrying the shed-

roofed entrance hood are replacement or added turned, turn-of-the-century posts. A secondary staircase is located between the two rooms on the eastern end of the house, a regional feature that is found in other houses of the period in Westport as well as Wilton. The articulated entablature is finished with cornice returns on the gable ends which are also set with lunette windows. A lean-to addition extends the house on the rear. The house is extremely well preserved on the interior as well as the exterior.
