HISTORIC RESOURCES INVENTORY - BUILDING AND STRUCTURES

Building Name (Common) Hiram St. John-Jennings House
Building Name (Historic) Hiram St. John House
Street Address or Location 49 Church Street 12/92
Town/City Wilton Village _____ County Fairfield
Owner(s) Quellette, Eileen M, & Roger M. ☐ Public ☒ Private

49 Church Street, Wilton

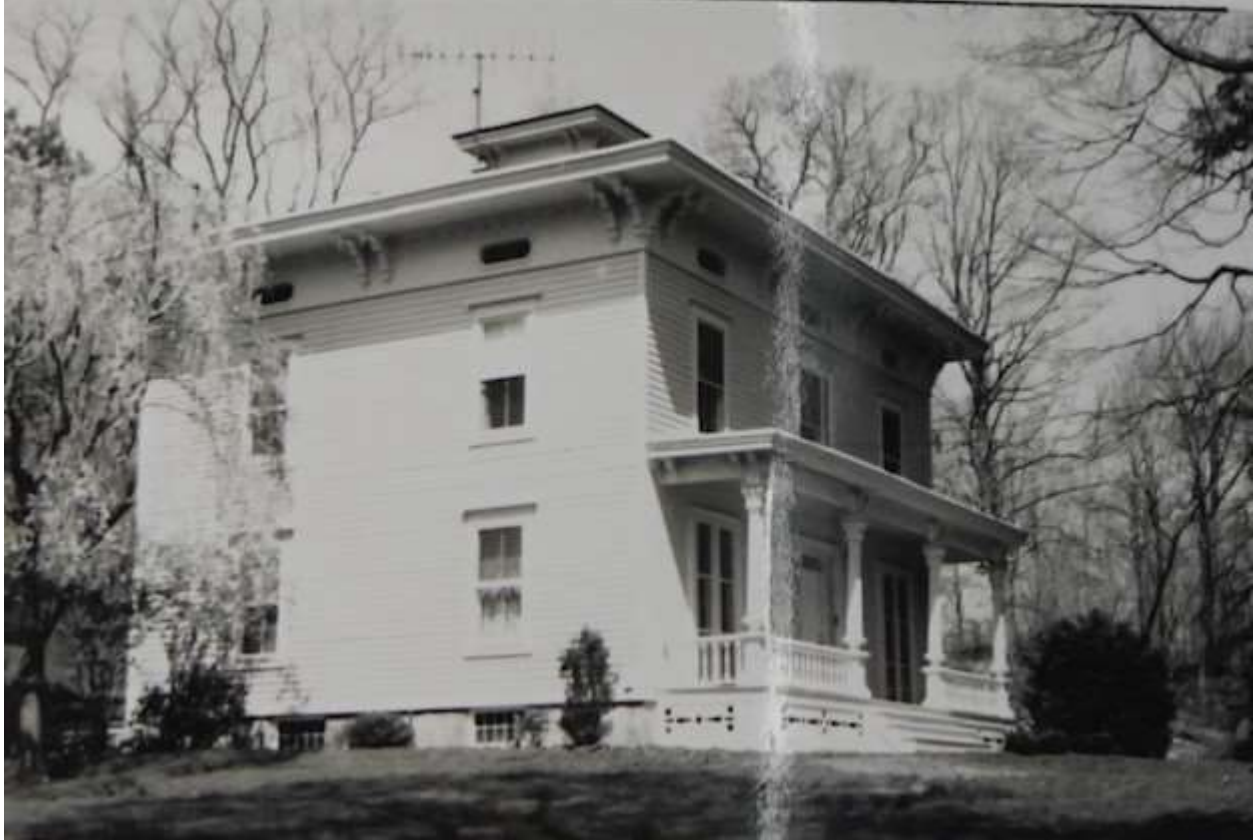
Photograph 49 Church Street. View southeast.

The superb, shallow hip-roofed, three-bay Italianate house arranged on the central hall plan ranks as one of the finest 19th-century dwellings in all of Wilton. Boldly proportioned and chastely detailed, the house has coupled brackets under the overhanging eaves and a frieze panel pierced by clipped corner, oval windows. A belvedere with the same eave detail crowns the roof. The central bay is emphasized on the second level by a pedimented frontispiece at the two-over-two window which a large door with large oval panels with bead and spool moldings. It is flanked by sidelights and a transom in a simple frame with a molded back band. Full-length casement windows provide access to the full façade, flat-roofed veranda set with distinctive posts with stylized capitals. They're reminiscent of Henry Austin's work in New Haven. The posts are on pedestals with

applied panels and rosette decoration. The veranda foundation enclosures are flat, sawn millwork. A large, rear service ell is sent to the rear of the main block. Two-over-two windows are used through the extremely gracious and well-preserved house. The Italianate style is well represented in Westport, but this is one of two known examples of the suburban villa house form in Wilton.
