## HISTORIC RESOURCES INVENTORY - BUILDING AND STRUCTURES

Building Name (Common) Davis-Weitzel House

Street Address or Location 759 Ridgefield Road

759 Ridgefield Road, Wilton

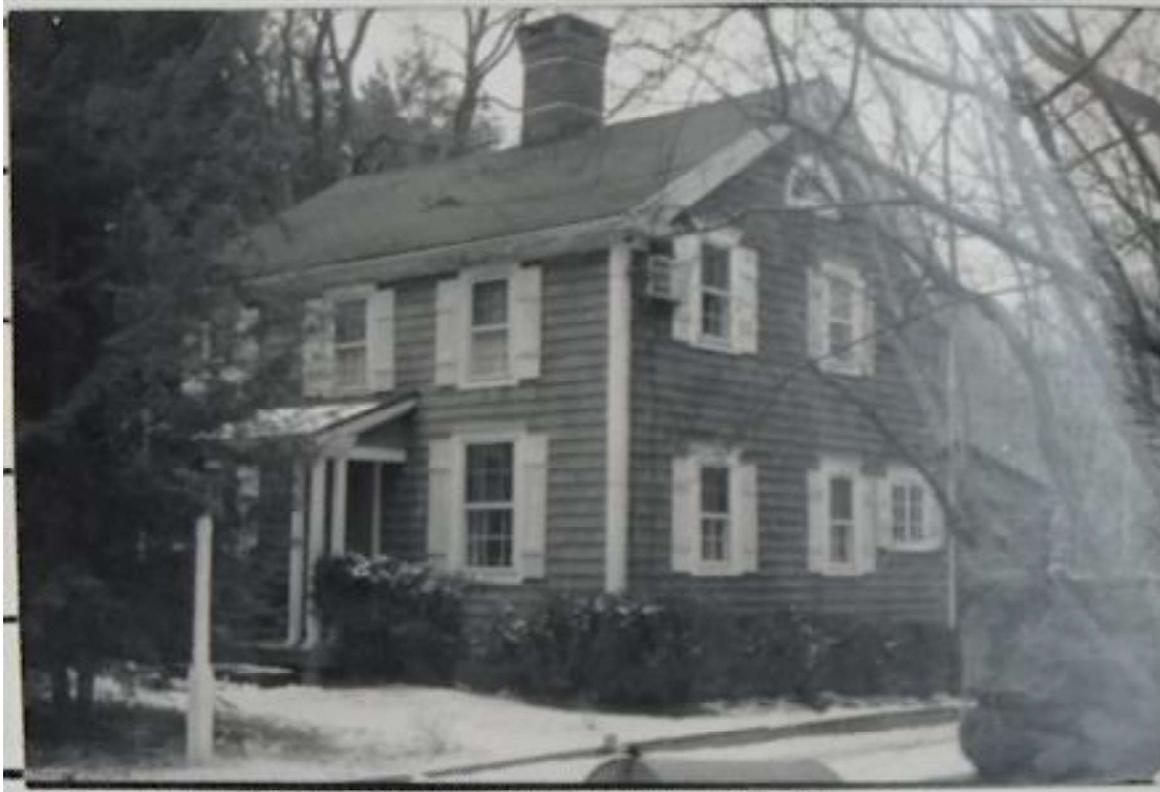
Photograph 759 Ridgefield Road View Northeast

The three-bay, central chimney, Federal style house with boxed overhanging eaves and cornice returns on the gable ends was redone in the Colonial Revival style in the 1960's. While some of the six-over-six windows appear to be original, those on the façade are replacements as are the shutters used throughout. The lunette window in the gable ends also appear to be revival as does the shed-roofed porch with plain posts that shelters the front entrance. Stylistically the house is typical of the ca. 1830 period in Wilton as it is typical of the mid-20<sup>th</sup> century attitude toward colonial and federal buildings.
