HISTORIC RESOURCES INVENTORY - BUILDING AND STRUCTURES

Building Name (Common) Stannard House

Building Name (Historic) Isaac Abbott House

Street Address or Location 760 Ridgefield Road

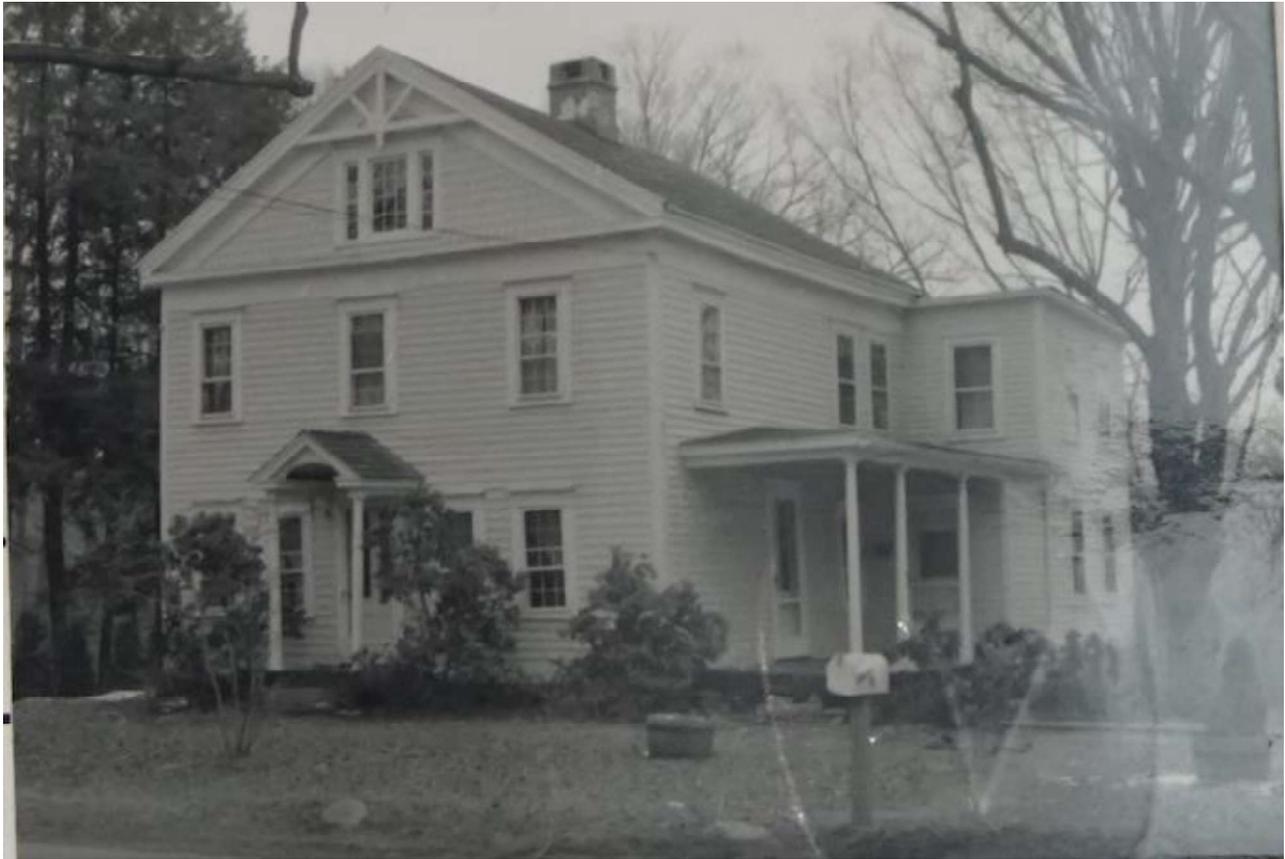
Photograph 760 Ridgefield Road View Southwest

The 2-story, gable-ended house is an interesting *mélange* of architectural styles. The house began as a 5-bay, central entrance cape built early in the 19th century. Toward the middle of the century, it was enlarged into a gable-ended, Greek Revival dwelling with a pedimented gable end and 3 bays on the second level. The flush-sided tympanum is filled with a tripartite window with double-hung sash. During the later part of the 19th century, the house was refreshed in the picturesque taste; a Stick Style gable piece was added to the front as was a wrapping verandah. This century, after 1965, the verandah was removed from the façade and replaced with an arched soffit entrance porch. The southern wrap of the verandah, set with Tuscan colonettes, was retained. The flat-

roofed, two-story ell added to the southeast corner of the house appears to date to late-19th or early 20th century. Many two-story houses in Wilton began as capes.
