HISTORIC RESOURCES INVENTORY - BUILDING AND STRUCTURES

Building Name (Common) Nelson Hanford House

Street Address or Location 1 Grumman Hill Road (Formerly 72 Danbury Road) 68/22

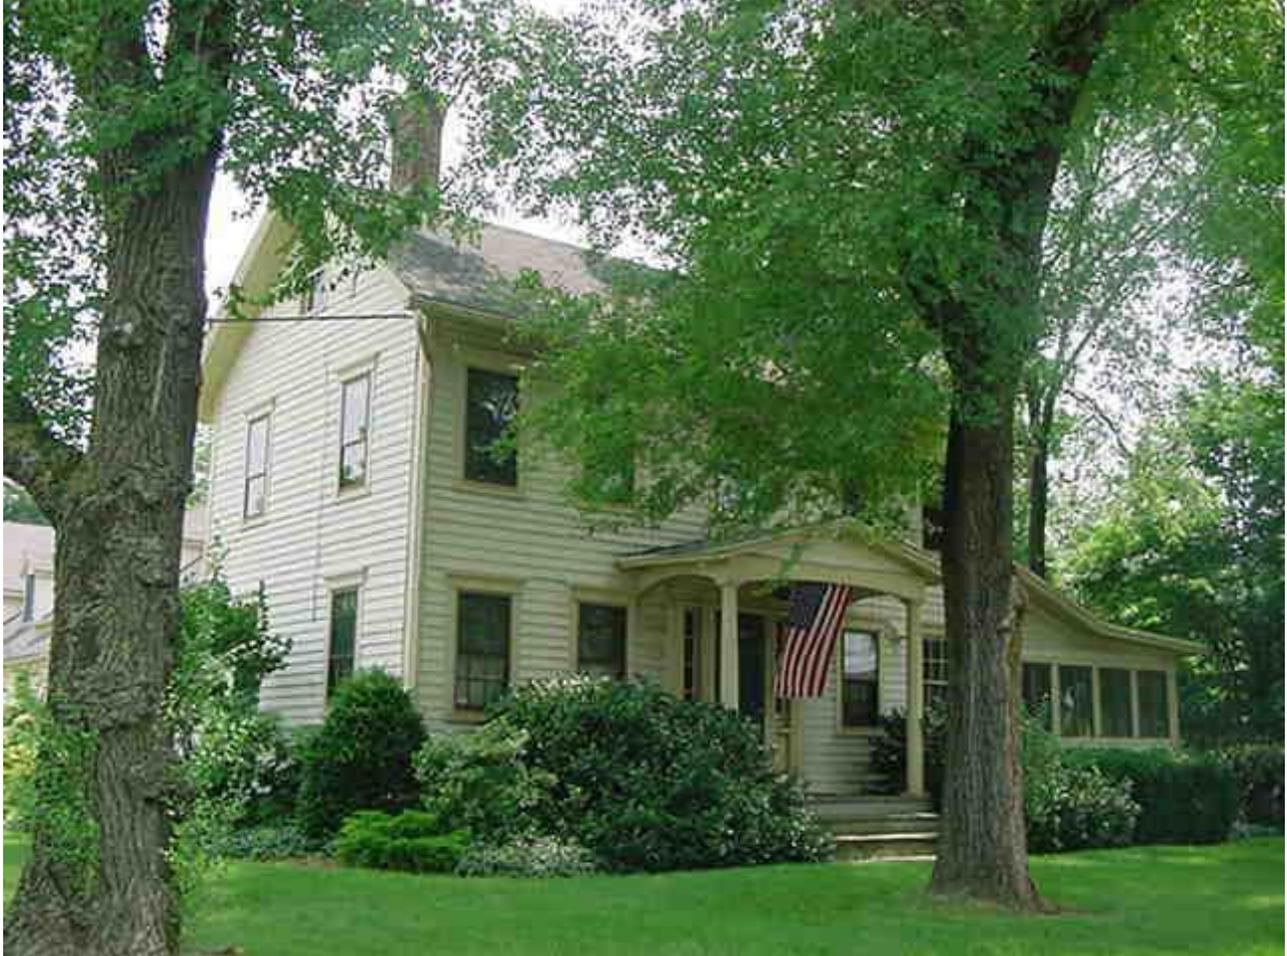
Photograph 1 Grumman Hill Road. View southwest.

The five-bay by two-bay, T-shaped, central hall plan house with interior end chimneys is set on a granite foundation and appears to date to ca. 1846. Six-over-six windows are used throughout and the central entrance, features a Colonial Revival door surrounded by a handsome Grecian tripartite frontispiece with molded pilasters, is sheltered by a pedimented portico with revival Tuscan columns. The roof with boxed, overhanging eaves does not appear to be original. The house has been enlarged many times with the wings and solarium on the south side appearing to date from the late 19th and early 20th century. The rearmost ell is recent. The Hanford House contributes
