HISTORIC RESOURCES INVENTORY - BUILDING AND STRUCTURES

Building Name (Common) St. Matthew's Episcopal Church

Street Address or Location 254 Danbury Road

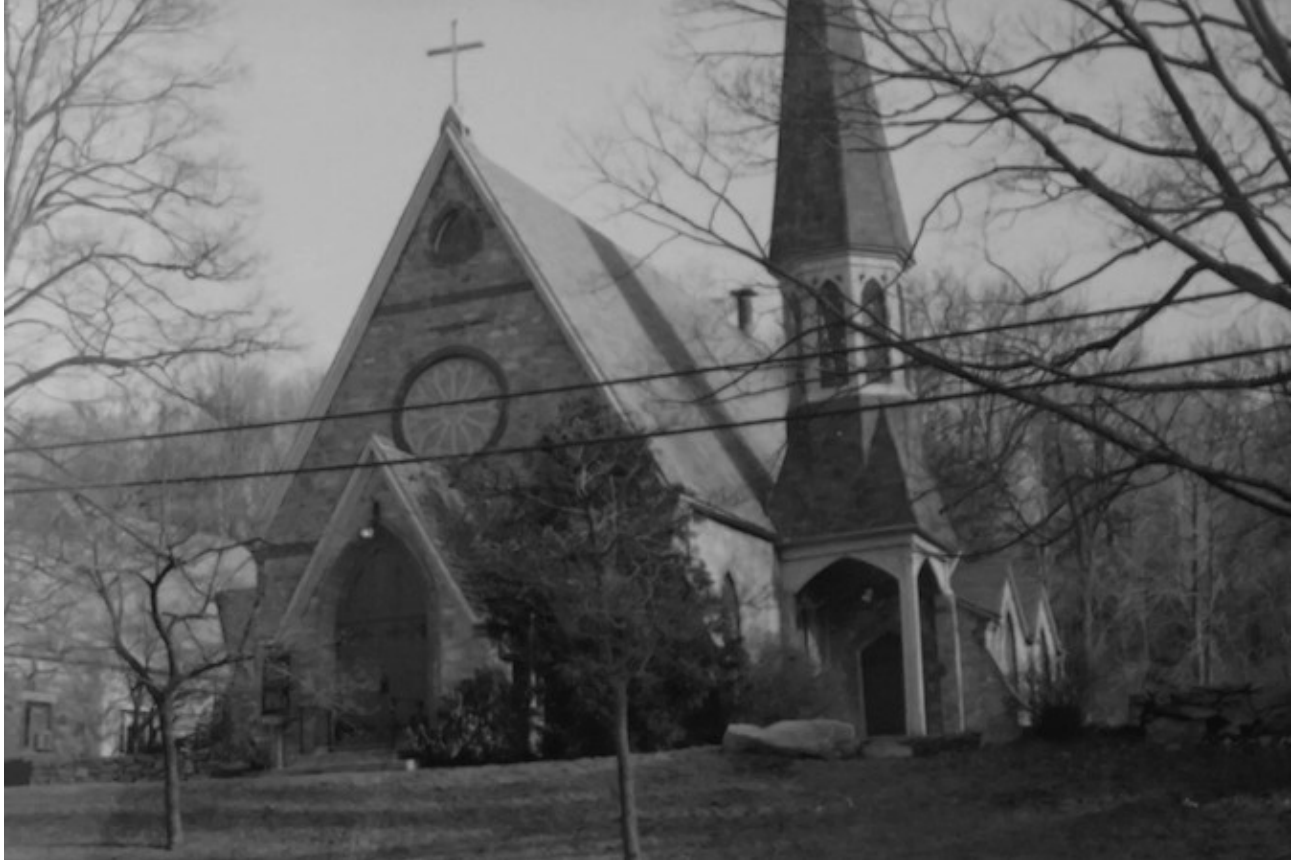
Photograph 254 Danbury Road. View Southwest.

The distinctive, English Tudor fieldstone and brick church set gable end to the street is an excellent example of the picturesque ecclesiastical structures that were promoted by the Episcopal church during the second half of the 19th century. Superbly massed and detailed with a steep roof, flat buttresses and a rose window at the end of the nave, the church is very well preserved. The corresponding entrance porch retains its original slate roof and is set with double-leaf, lancet entrance doors and a drip molding. The lancet motif is repeated in the fenestration with brick surrounds on the secondary elevations. A 1971 fire destroyed the original windows. The octagonal

belfry with a steep spire is set on an open square porch with Tudor arches. Equally as well designed is the parish hall added to the north side in 1939-40 and the two-story Sunday school wing completed in 1954. The church is one of the finest ecclesiastical structures in Wilton.
