HISTORIC RESOURCES INVENTORY - BUILDING AND STRUCTURES

Building Name (Common) Scott-Raymond House
Building Name (Historic) William Scott House
Street Address or Location 121 Millstone Road
Town/City Wilton Village _____ County Fairfield
Owner(s) Gerlin, Robert A. and Juliet R. ☐ Public ☒ Private

CONTINUATION SHEET 121 Millstone Road, Wilton

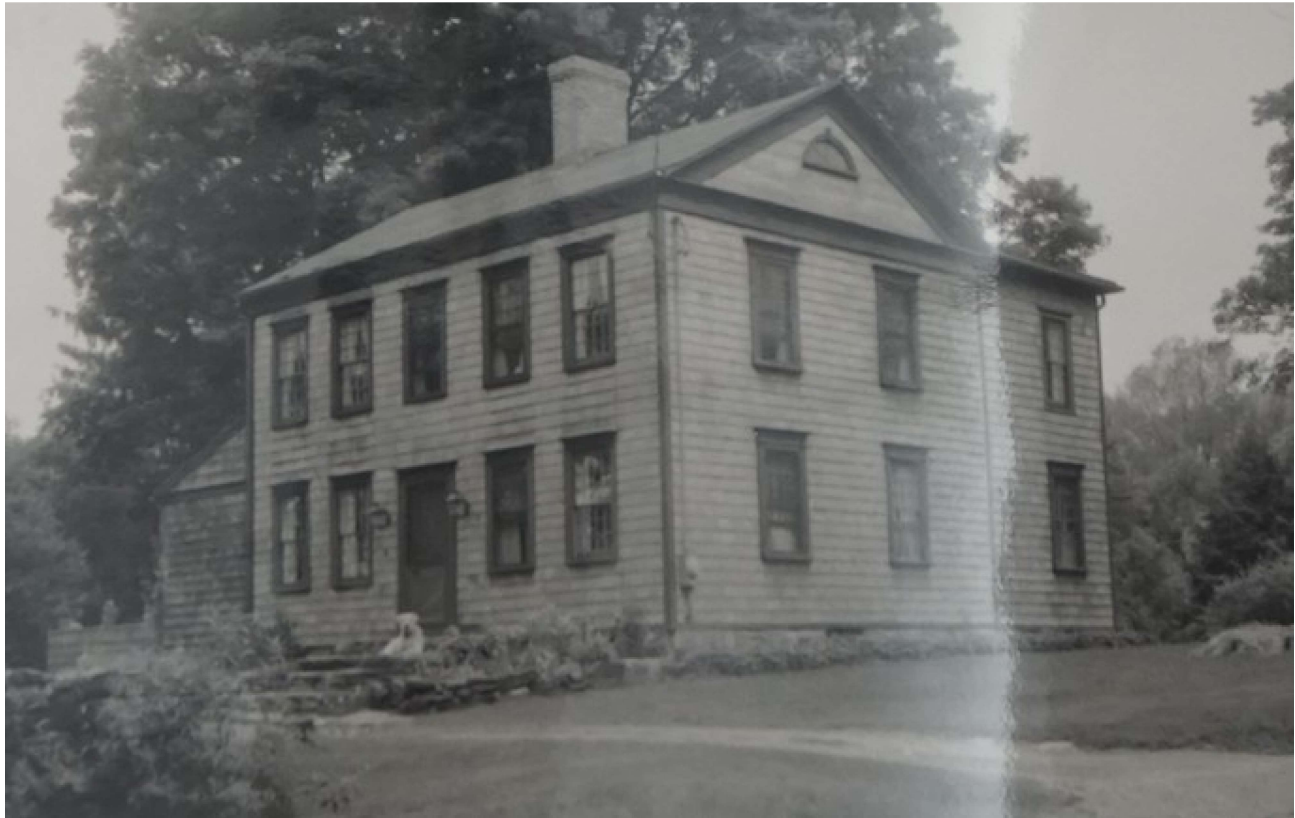
Photograph 121 Millstone Road View

The easterly oriented, single-pile, five-bay by two-bay, gable-roofed dwelling appears to date to the late 1790s or early 1800s, but since it was remodeled twice during the 19th century, little original exterior fabric or styling survives. Most indicative of the ca. 1800 house is the south elevation with its flush eaves and six-over-six windows. Mid-century the north (side) elevation and east (facade) were reworked by the addition of a continuous entablature that creates a pedimented gable end. The entrance bay is filled with a six-panel door. During the late-19th century a large, two-story rear ell was added where most likely a verandah existed that has been removed. After 1923 the house was extensively remodeled in the colonial Revival mode with a

lunette window in the flush-sided, north gable end and twelve-over-twelve windows with molded backbands. Unfortunately, the shingle-sheathed house has been sandblasted.
