HISTORIC RESOURCES INVENTORY - BUILDING AND STRUCTURES

Building Name (Common) Campbell-Avellar House
Building Name (Historic) Unknown
Street Address or Location 208 Millstone Road
Town/City Wilton Village _____ County Fairfield
Owner(s) Behan, John W. Jr. ☐ Public ☒ Private

CONTINUATION SHEET 208 Millstone Road, Wilton

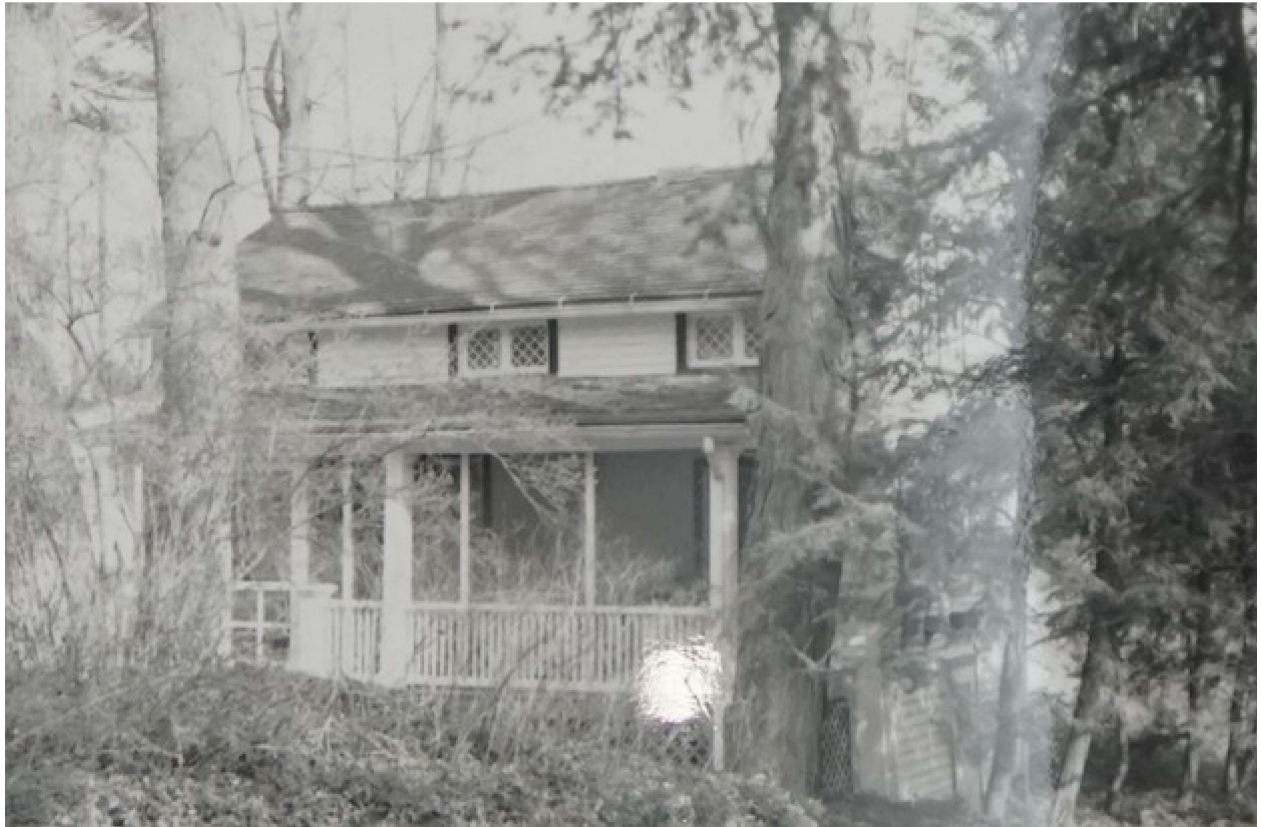
Photograph 208 Millstone Road View West

Located on a high, wood lot on the north side of winding Millstone Road.

The small, one and one-half -story house set gable end to the road may incorporate a mid-19th century structure. It was reworked ca. 1915 in the Colonial Revival mode. A Tuscan-columned verandah shelters the southerly side, and diamond-paned, casement windows are set under the eaves. The same motif is used for the double hung windows on the main level. A boxed cornice returns on the gable ends. The house is located very close to the road, and it appears to be well preserved.

The small, gable-roofed house set close to the road appears to be in the same location as one depicted on the early maps of Wilton, but it is not known if that building is incorporated within this structure. In 1910 dr. John B. Campbell and his wife Leonora began acquiring property in the vicinity. They maintained a seasonal residence at 296 Millstone Road. It appears that this parcel was purchased from Lew Olmstead's estate in 1912 (29:168). It is assumed that the Campbells reworked the house in the Colonial Revival style and used it as a caretakers or guest cottage. They sold to Florence Lemmon in 1924, and she in turn conveyed it to Ruth Kerby the same year (37:40). Katherine Avellar of New York City purchased the house in 1941, and she retained it until 1968 (49:427). It appears to be a mid-19th century house reworked during the early decades of this century.
