HISTORIC RESOURCES INVENTORY - BUILDING AND STRUCTURES

Building Name (Common) Charles Comstock House

Street Address or Location 196 Danbury Road 56/12 30/31

196 Danbury Road, Wilton

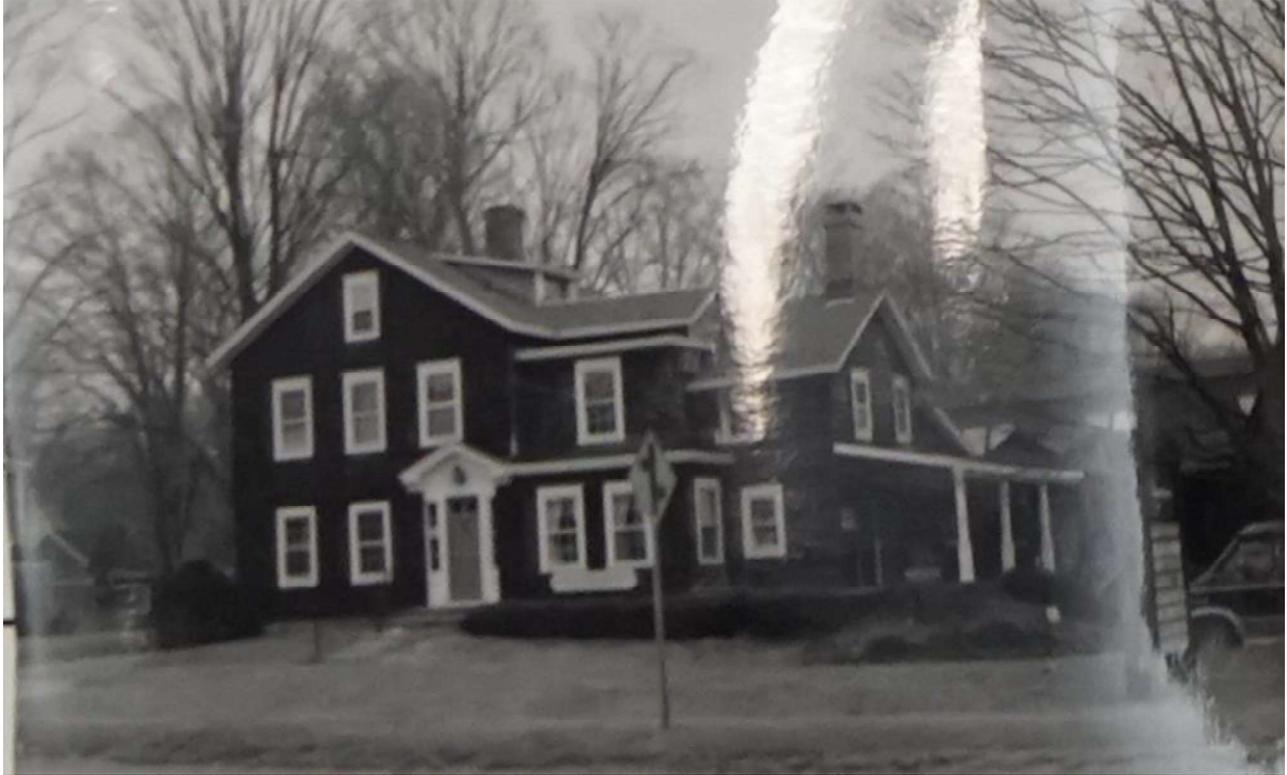
Photograph 196 Danbury Road. View southwest.

The shingled, three-bay, gable-ended, vernacular house with boxed, overhanging eaves and a recessed, two-story, flat-roofed ell on the south is similar in mass and plan to its neighbor to the north. Six-over-six windows are used throughout, and the entrance is set with a later, Colonial Revival frame with narrow sidelights and shallow, pedimented hood. The house has been greatly enlarged by a myriad of what appear to be late-19th and 20th-century additions to the south and rear elevations. The large, modern wing off the southeast corner is recessed so as to not overpower the original/early house. The building is now used as an office space.
