HISTORIC RESOURCES INVENTORY - BUILDING AND STRUCTURES

Building Name (Common) Sherman Morehouse House

Building Name (Historic) Raymond-Morehouse House

Street Address or Location 198 Danbury Road 56/11

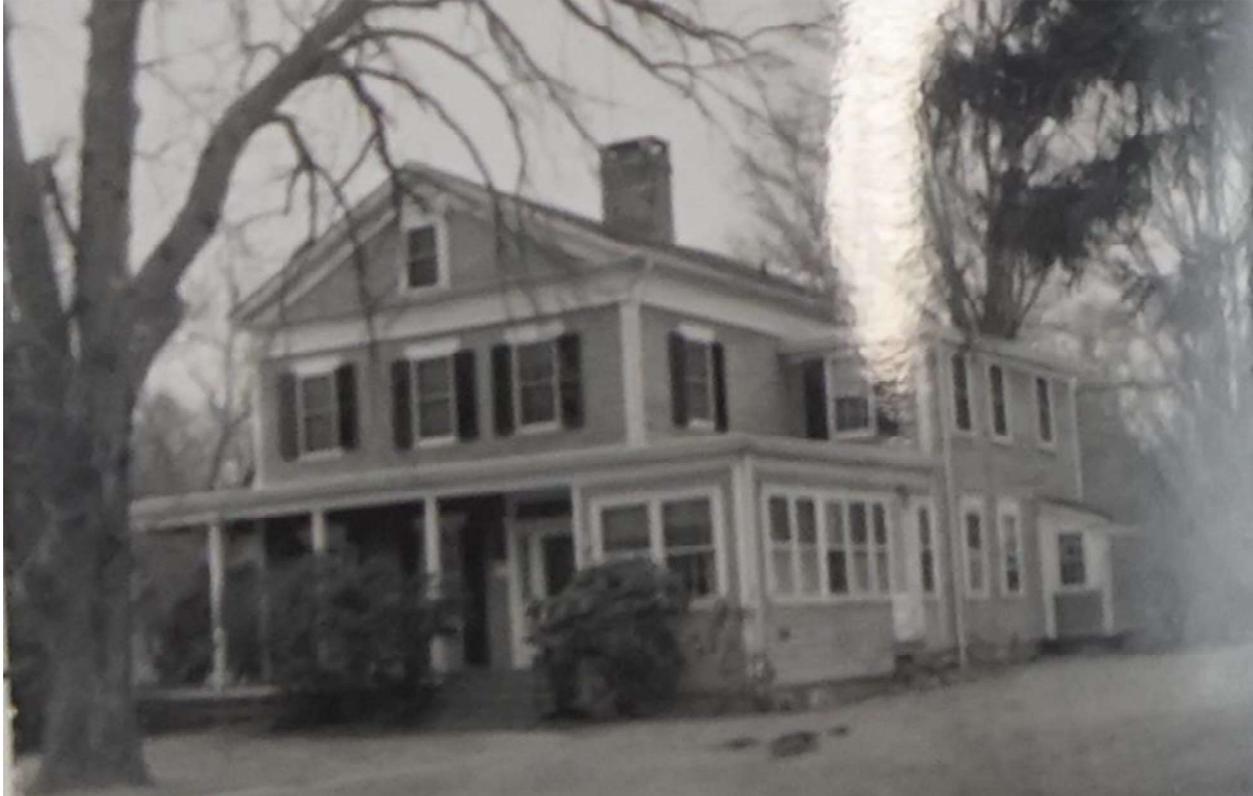
Photograph 198 Danbury Road. View southwest.

The gable-ended, three-bay dwelling is superbly detailed in the Grecian taste and ranks as one of the best examples of the style in Wilton. The pedimented gable end has an articulated entablature, which is continued on the secondary elevations, and the flush-sided tympanum is set with a six-over-six window surrounded by a frontispiece. The offset entrance features a superb Greek Revival, pilastered frontispiece and sidelights with geometric pattern muntins as well as a small-light transom. The full façade veranda appears to be a alter addition and it has simple, plain posts. It wrapped to a flat-roofed, two-story ell on the south elevation, but the southern end of the veranda has been enclosed to create a solarium. The house appears to be arranged on the typical, four-room plan. It is very well preserved.
