HISTORIC RESOURCES INVENTORY - BUILDING AND STRUCTURES

Building Name (Common) Vollmer House

Street Address or Location 359 Belden Hill Road (Now 345 Belden Hill Road)

359 Belden Hill Road, Wilton

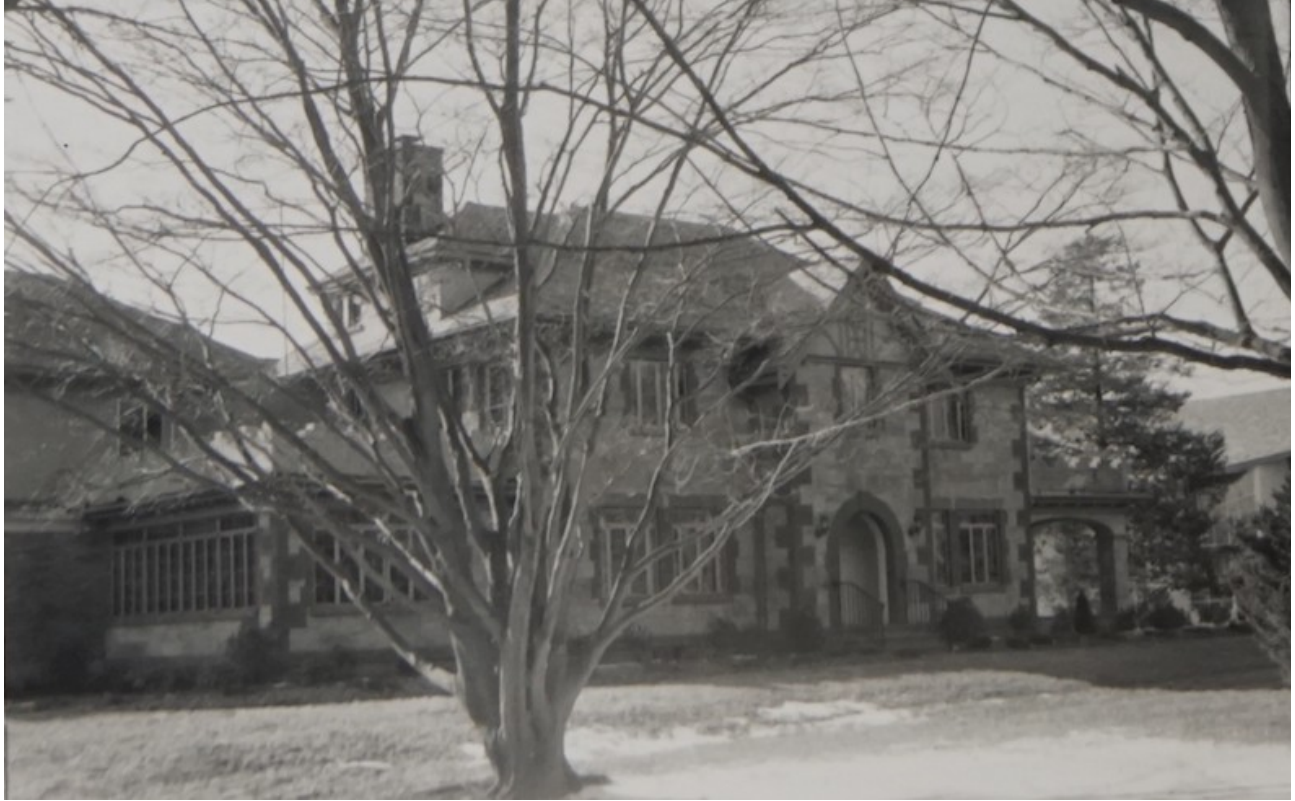
Photograph 359 Belden Hill Road. View southeast.

Ambitious, architect-designed, Tudor Revival house was constructed after 1930. Built of fieldstone with brownstone accenting, the five-bay, hip-roof mass is a nice play of textures increased by the slate roof which is pierced by hipped dormers. The gable-ended entrance porch has a decorative bar dashboard and mock half-timbering. Stylized modillions are set under the overhanging eaves. Leaded casement windows are used throughout. The south solarium, with a crenelated parapet, is matched by an open porch on the north side. A two-story, service ell is located off the rear of the house. The house was enlarged after 1957, when it was acquired by the Catholic Church. The grounds have been developed with modern buildings, but the front portion retains its original graciousness.
