HISTORIC RESOURCES INVENTORY - BUILDING AND STRUCTURES

Building Name (Common) Gilbert-Smith House

Street Address or Location 45 Belden Hill Road

45 Belden Hill Road, Wilton

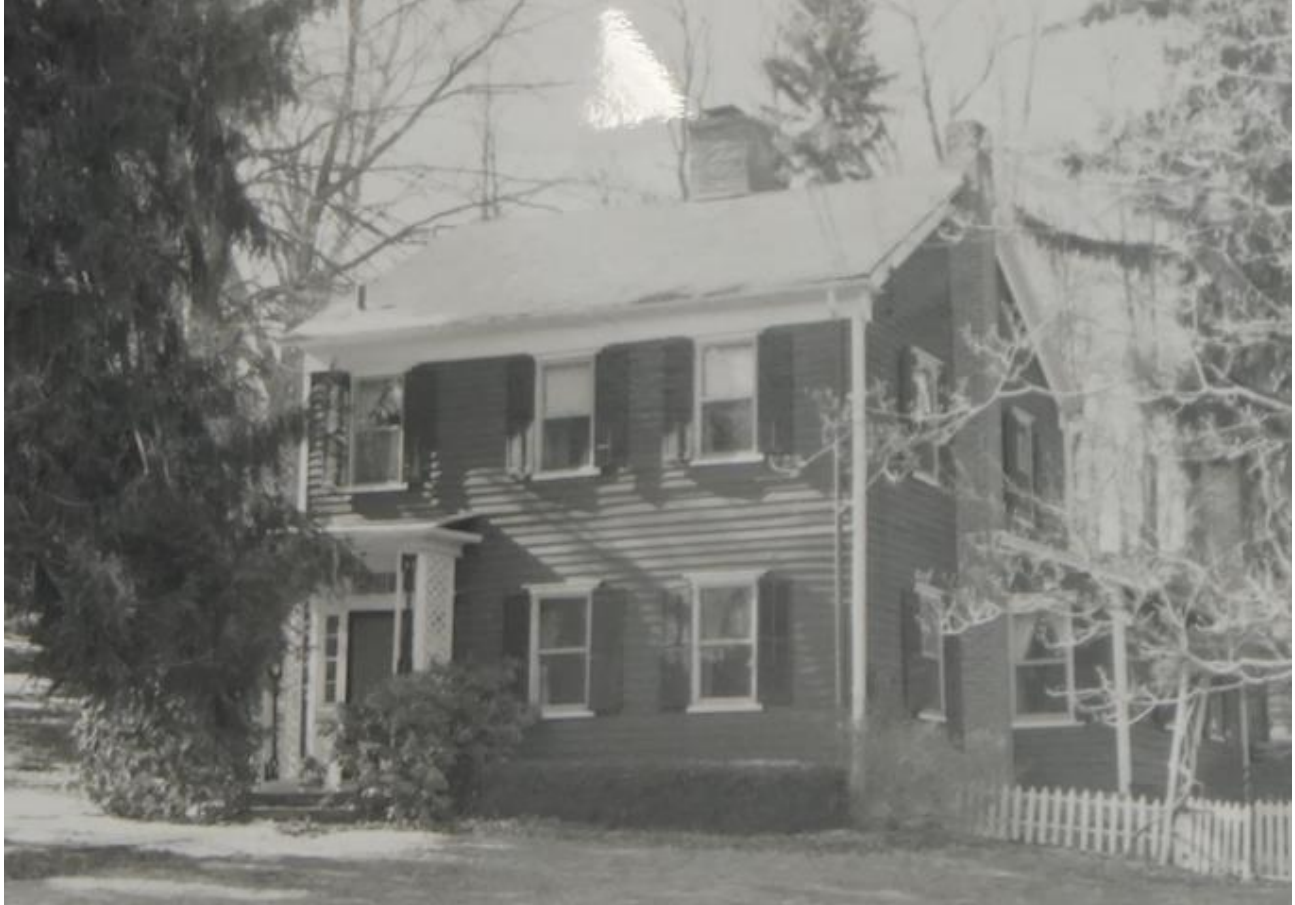
Photograph 45 Belden Hill Road. View northeast.

The central chimney, three-bay, offset entrance, Federal transitional house is reasonably well preserved. It is finished with a frieze board and cornice returns typical of the period. The handsome, partite frontispiece in the Greek style and pent roof sheltering it are original, but the six panel entrance door and porch posts are not. Most of the original six-over-six windows (one survives) have been replaced with one-over-one sash. A small, shed roofed ell has been added to the east side of the house and a large wing extend it on the rear.
