HISTORIC RESOURCES INVENTORY - BUILDING AND STRUCTURES

Building Name (Common) Lyon-Nathan House

Building Name (Historic) Lyon Tavern

Street Address or Location 923 Ridgefield Road

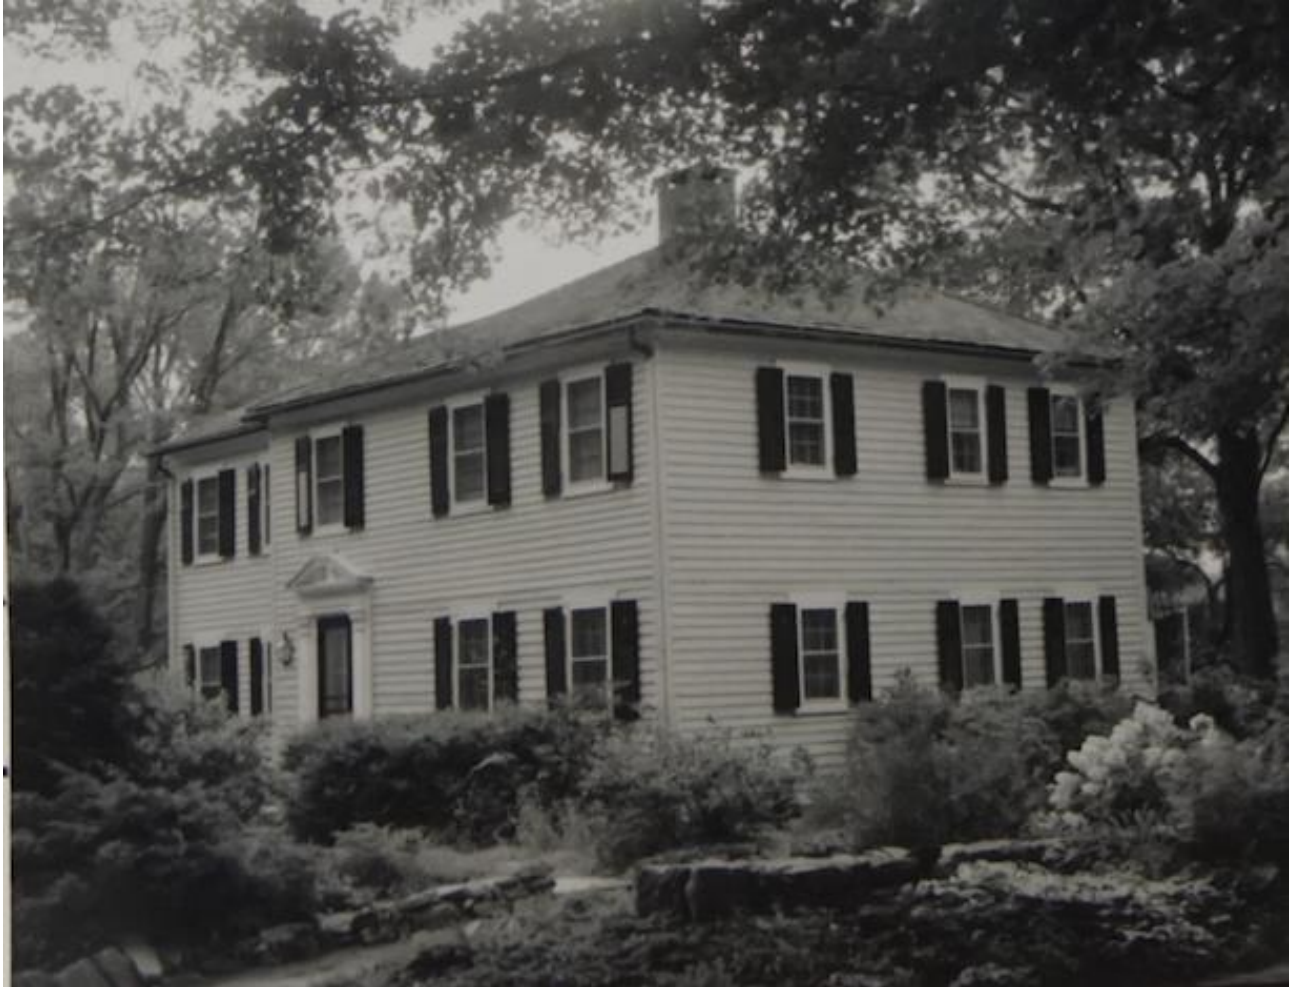
Photograph 923 Ridgefield Road View Northeast

The three-bay, side hall plan, Federal-style house is, along with Marvin Tavern, the only documented local example of an original pyramidal hip roof. The six-over-six windows diminish on the second level. The house has been reworked twice; once in the late 19th century and again this century in the Colonial Revival mode. Historic photographs show that the façade was

sheltered by a verandah with turned posts, and, while it has been removed, the entrance door with a glazed upper panel which was probably added at the same time, survives. It is framed by a broken pediment frontispiece that is Colonial Revival as are the shutters. A two-story wing has been added to the south side. A stone terrace is located at the rear of the house which sits on nicely landscaped grounds. A guesthouse is located at the rear of the property.
