HISTORIC RESOURCES INVENTORY - BUILDING AND STRUCTURES

Building Name (Common) 114 Sharp Hill Road
Building Name (Historic) _____
Street Address or Location 114 Sharp Hill Road
Town/City Wilton Village _____ County Fairfield
Owner(s) Crimmins, Thomas H. & Laura S. ☐ Public ☒ Private

CONTINUATION SHEET: 114 Sharp Hill Road, Wilton, CT

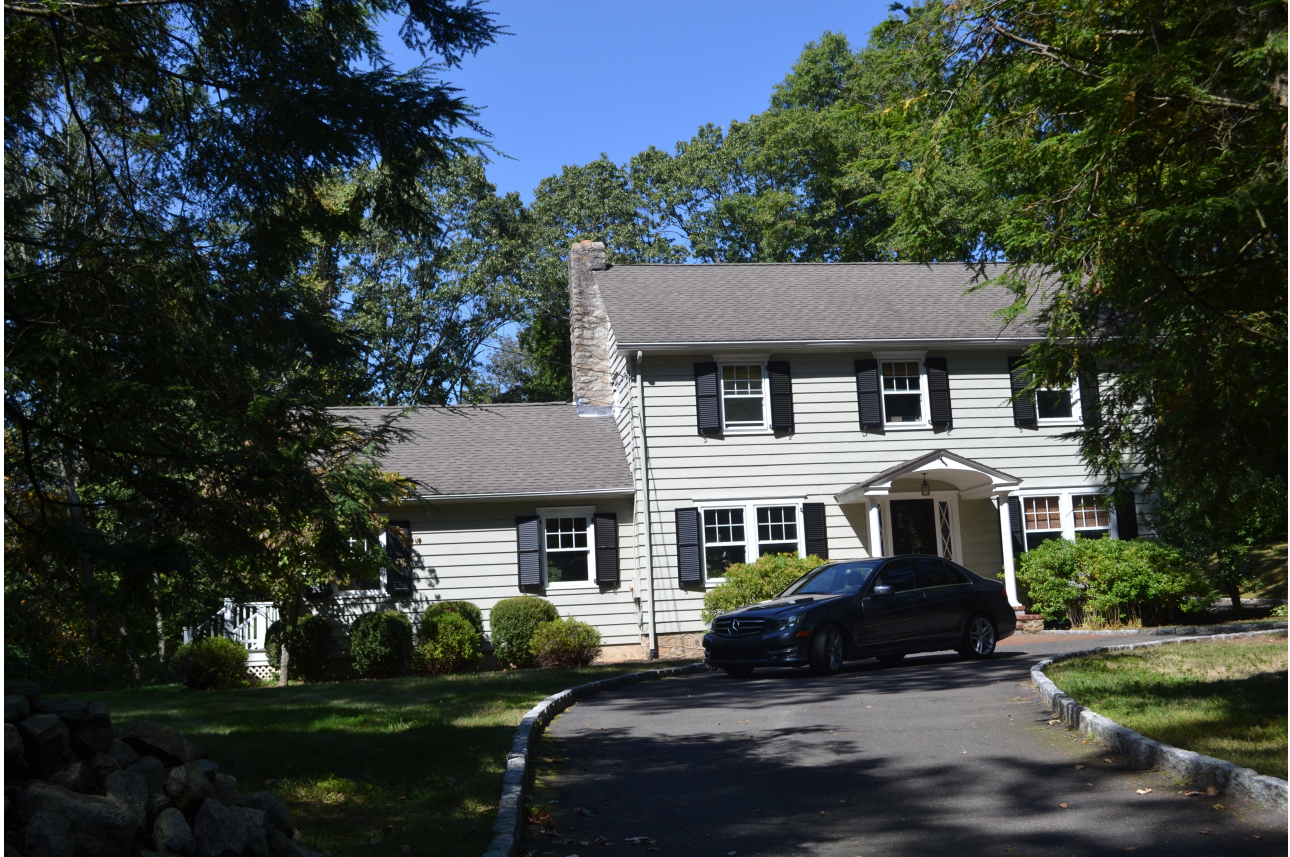
Photograph of 114 Sharp Hill Road, view facing northwest.

The house at 114 Sharp Hill Road is a two-story, wood-frame, Colonial Revival-style residence built ca. 1925. It has a side-gabled roof and is oriented with its ridgeline set roughly north-south parallel to the street. A modern one-story ell with a side-gabled roof adjoins the south (side) elevation of the main block. The

house is clad in aluminum siding and rests on a concrete foundation. There are moderate overhangs of the asphalt-shingled roof at the eaves and rakes and a rubblestone masonry gable-wall chimney rising from the south (side) elevation of the main block. The primary entrance to the house is centered within the three-bay east (façade) elevation. It consists of a paneled wood entry door set in a plain wood frame and flanked by multipane sidelights with diamond-shaped glazing. The entry is sheltered by a one-story porch with Tuscan columns, a front-facing gable roof, and a flat-arched underside. Paired six-over-one double-hung windows are located in each of the flanking bays, while a single six-over-one double-hung window can be found in each of the three bays above. Fenestration throughout the remainder of the house likewise consists of six-over-one double-hung windows. A secondary entrance to the residence is located on the north (side) elevation.
