HISTORIC RESOURCES INVENTORY - BUILDING AND STRUCTURES

Building Name (Common) 39 Grumman Hill Road

CONTINUATION SHEET: 39 Grumman Hill Road, Wilton, CT

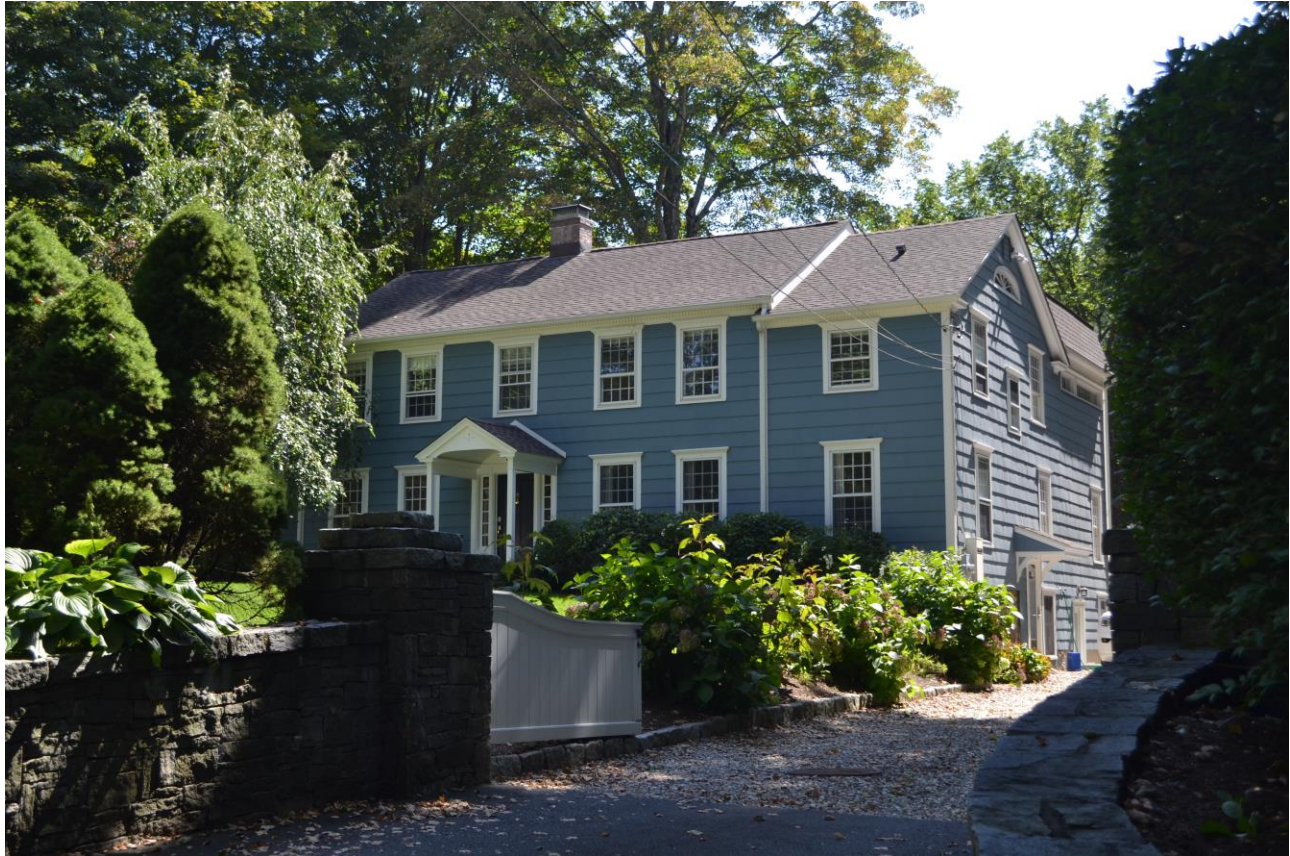
Photograph of 39 Grumman Hill Road, view facing southeast.

The house at 39 Grumman Hill Road is a two-story, wood-frame, Colonial Revival-style residence built ca. 1929. It has a side-gabled roof and is oriented with its ridgeline set roughly east-west parallel to the street. There is a two-story side-gabled ell adjoining the main block's west (side) elevation and a two-story cross-gable wing extending from both the west end of the main block's south (rear) elevation and the south (rear)

elevation of the western ell. The house is clad in wood shingles and a denticulated cornice extends across the primary eavelines. A central brick chimney rises from the ridgeline of the main block. There are minimal overhangs of the asphalt-shingled roof at the eaves, rakes, and cornice returns. The primary entrance to the house is centered on the five-bay façade of the main block where it is sheltered by a one-story porch with square supports, front-facing gable roof, and a curved underside. The paneled wood entry door is flanked by six-light sidelights. Fenestration throughout the first floor of the house primarily consists of 12-over-12 double-hung windows with molded wood surrounds, while that on the second story primarily consists of similar eight-over-eight arrangements. There are round-arched fanlights in the gable-ends of the main block and west ell, and a secondary entrance sheltered by a shed-roof portico on the west (side) elevation of the west ell.
