HISTORIC RESOURCES INVENTORY - BUILDING AND STRUCTURES

Building Name (Common) Hardej House

Building Name (Historic) Johnson-Maloney House

Street Address or Location 763 Danbury Road

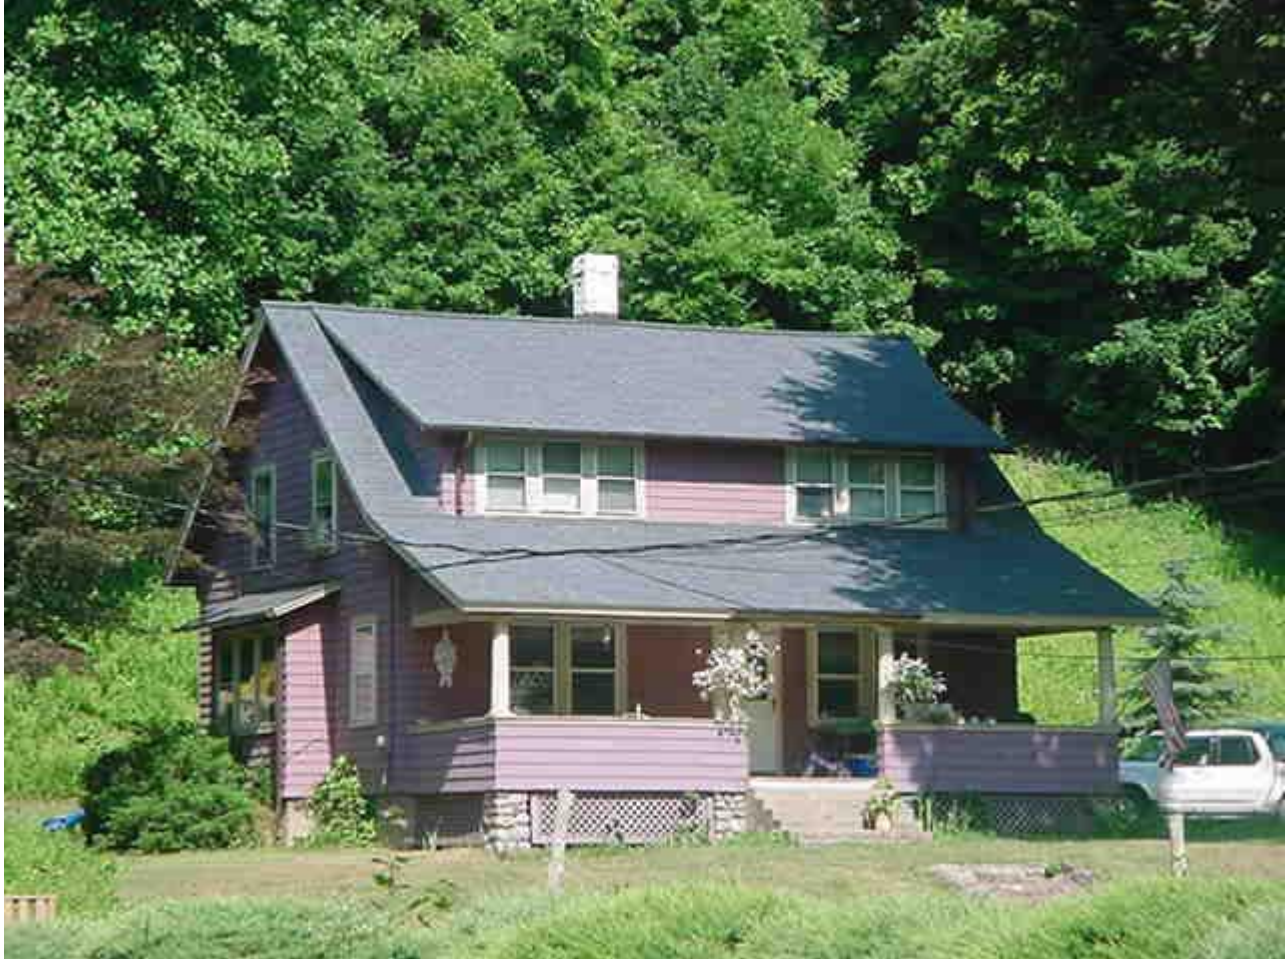
Photograph 763 Danbury Road. View East.

The well-preserved, sweeping gable-roofed, shingled Craftsman bungalow is a quintessential example of the style with an inset, front porch and deep, overhanging eaves. The porch has truncated Tuscan columns on a solid balustrade. Windows on the façade are coupled, and the

continuous shed dormer is set with two groups of three small windows. A shed-roofed, bay window opens the south elevation.
