## HISTORIC RESOURCES INVENTORY - BUILDING AND STRUCTURES

Building Name (Common) Foster-Castle House  
Building Name (Historic) Fred Foster House  
Street Address or Location 3 Church Street 12-103 2-20  
Town/City Wilton Village \_\_\_\_\_ County Fairfield  
Owner(s) Martin, Catherine E. ☐ Public ☒ Private

### 3 Church Street, Wilton

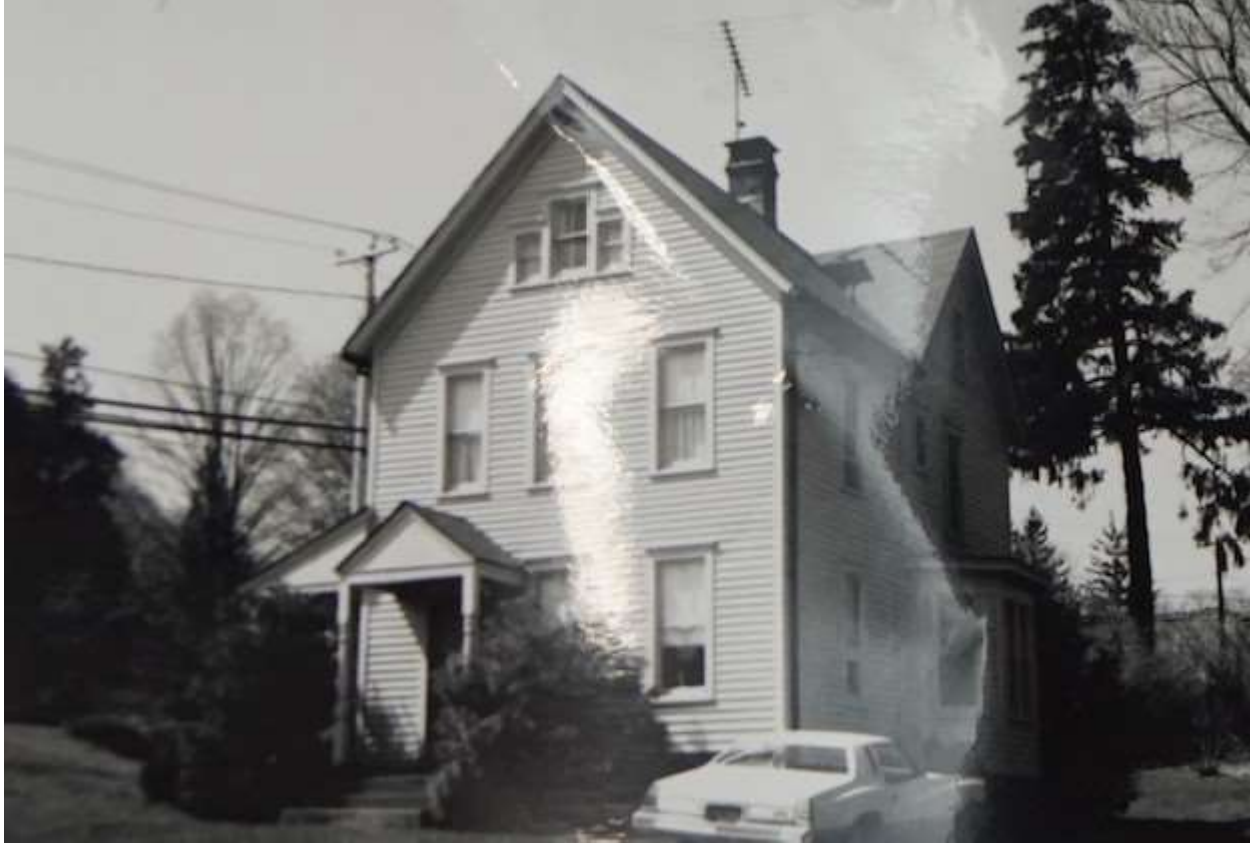
Photograph 3 Church Street. View northeast.

The large, well proportioned, L-shaped, picturesque vernacular house is well preserved and is one of the few local examples of the popular 1890s house form. With the exception of the removal of the portion of the wrapping veranda that shelters the façade, the house is well preserved. The side portion of the veranda survives with its heavy turned posts which are also used on the pediment at entrance porch. Large two-over-one sash are used throughout, in the gable end of the façade is filled with a tripartite window. A flat-roofed, octagonal-ended bay opens in the north elevation which also has a cross gable. The house is set on granite, ashlar foundation.
