HISTORIC RESOURCES INVENTORY - BUILDING AND STRUCTURES

Building Name (Common) Sturges - Blackmar House
Building Name (Historic) Betts - Sturges House
Street Address or Location 224 Danbury Road
Town/City Wilton Village _____ County Fairfield
Owner(s) Dana Blackmar, III Estate, Stylvia Neumann, Trustee ☐ Public ☒ Private

224 Danbury Road, Wilton

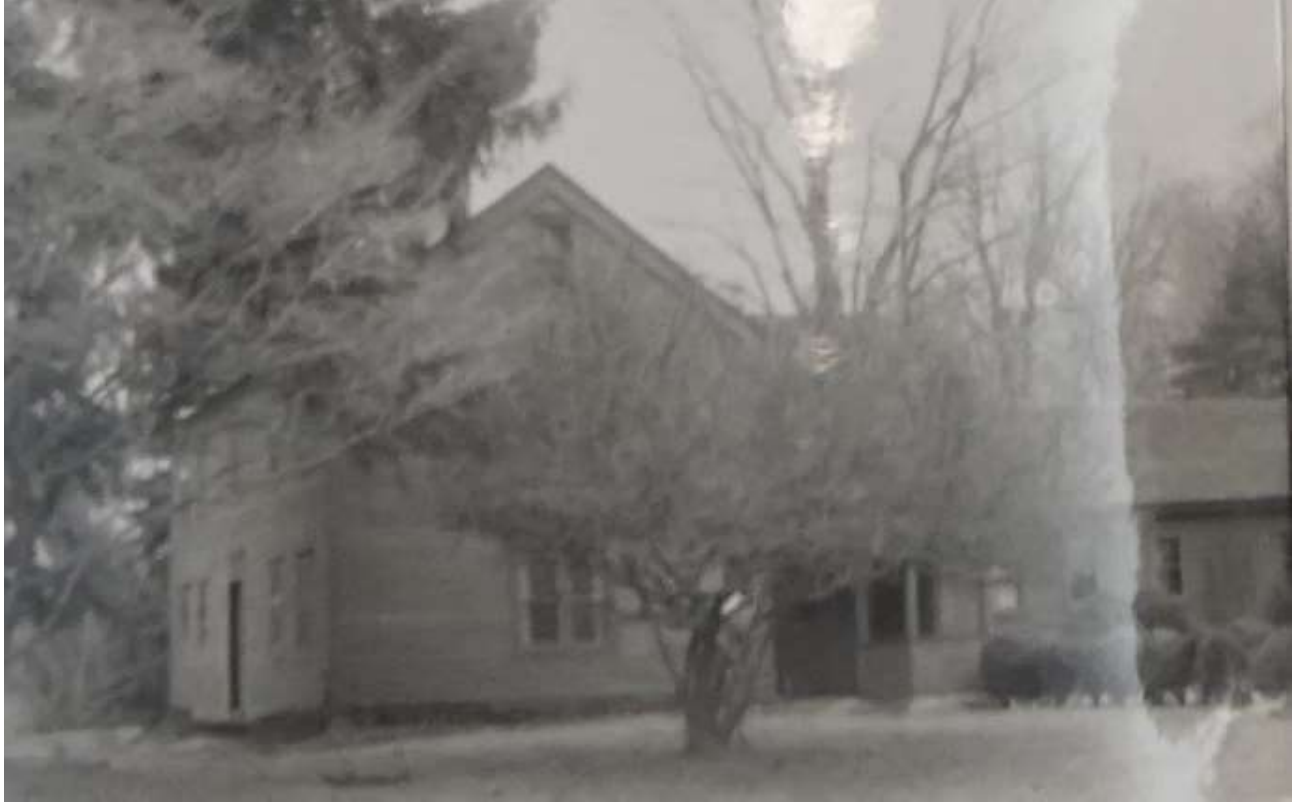
View Southwest Negative on File CTSHPO 1:17

The central chimney, five-bay, Colonial dwelling has been extensively reworked in the Colonial Revival style beginning in the 1920s. It is known that there were late-19th century, “improvements” made to the house, but they were removed this century. Nine-over-nine sash are used throughout and are coupled on the gable ends. The barge board and eave detail appear to be 20th century. The house has been extended to the rear with a two-story wing of corresponding design in this century. An apartment was located in the rear ell. The house was apparently originally constructed as a two-room, up-and-down dwelling which was later extended by a kitchen ell across the back. The framing is original, but most of the interior paneling was added by the current owner in the 1960s.
