## HISTORIC RESOURCES INVENTORY - BUILDING AND STRUCTURES

Building Name (Common) Brubeck House  
Building Name (Historic) Brubeck House  
Street Address or Location 221 Millstone Road  
Town/City Wilton Village \_\_\_\_\_ County Fairfield  
Owner(s) Brubeck, David W. and John, Trustees ☐ Public ☒ Private

### CONTINUATION SHEET 221 Millstone Road, Wilton

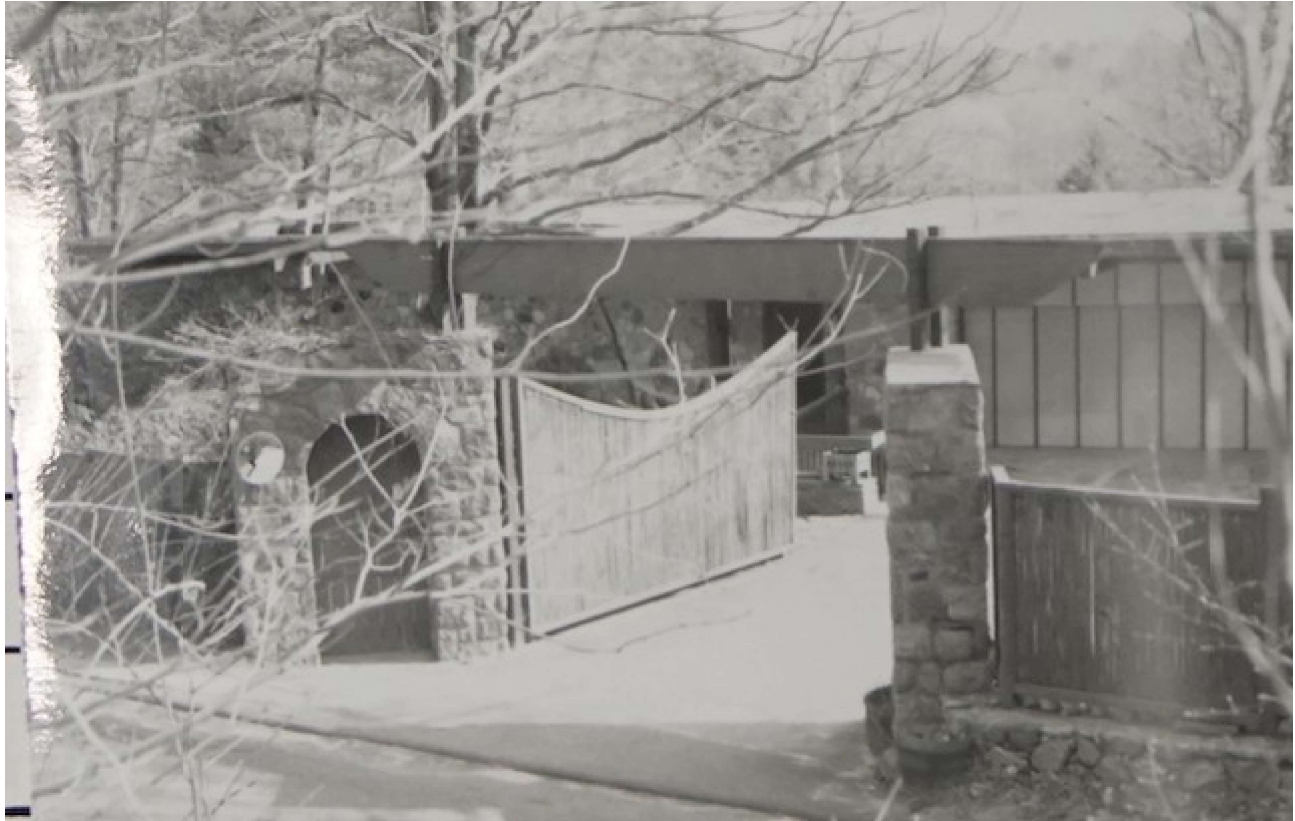
Photograph 221 Millstone Road View North

The contemporary house is set on a wooded lot and secluded from the road.

The contemporary, flat-roofed house set into the hill and oriented to the view at the rear of the house has a Oriental theme to the design, and it is built on the modular concept. Its open interior was favored by the family. The house appears to be a one-story with the main entrance and garage on the main level, but the site permits a lower level with walkout area in the rear. The façade is dominated by a curving, fieldstone wall, bands of windows on both levels, and a deep, overhanging roof that breaks to accommodate mature trees. It is enclosed from the road by a bamboo fence and Japanese-inspired gate with a massive lintel with shaped ends and a circular-headed garden gate. The low-slung house fits in well with its natural surroundings.
