HISTORIC RESOURCES INVENTORY - BUILDING AND STRUCTURES

Building Name (Common) Orem's Diner

Street Address or Location 209 Danbury Road 71/42 29/62 Demolished (marker moved)

CONTINUATION SHEET

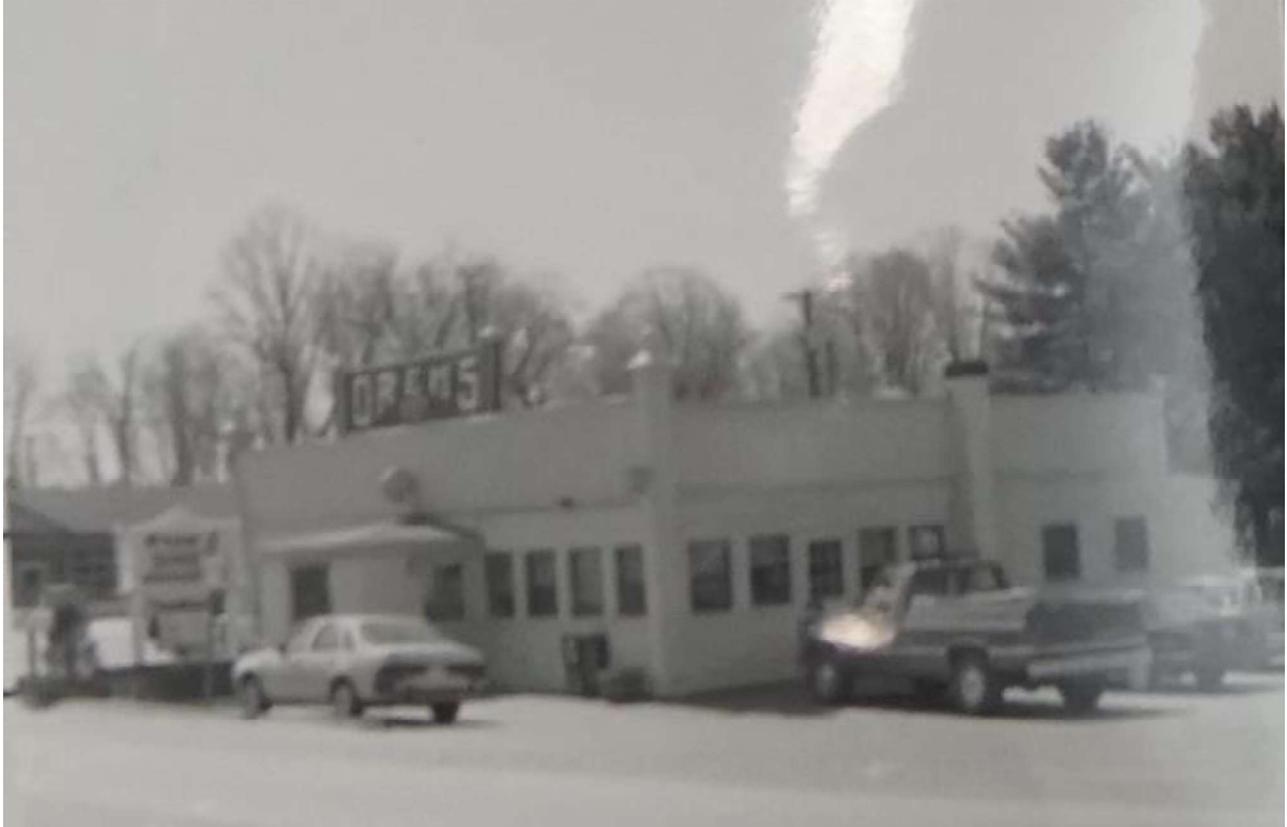
Photograph 209 Danbury Road. View northeast.

The boxy, flat-roofed structure with V-groove, Masonite siding and boxed, corner piers with large ball finials incorporate the original building (southern portion). An entrance vestibule is centered on the façade, and the bands of single-light windows slide up into pockets. The building has been extended to the rear and north. A large sign, with the same pier and finial detail as the main mass, is centered atop the stepped parapet that wraps three sides. The interior is not historic.
