## HISTORIC RESOURCES INVENTORY - BUILDING AND STRUCTURES

Building Name (Common) Raymond Farm

Building Name (Historic) Platt Raymond House

Street Address or Location 275 Hurlbutt Street

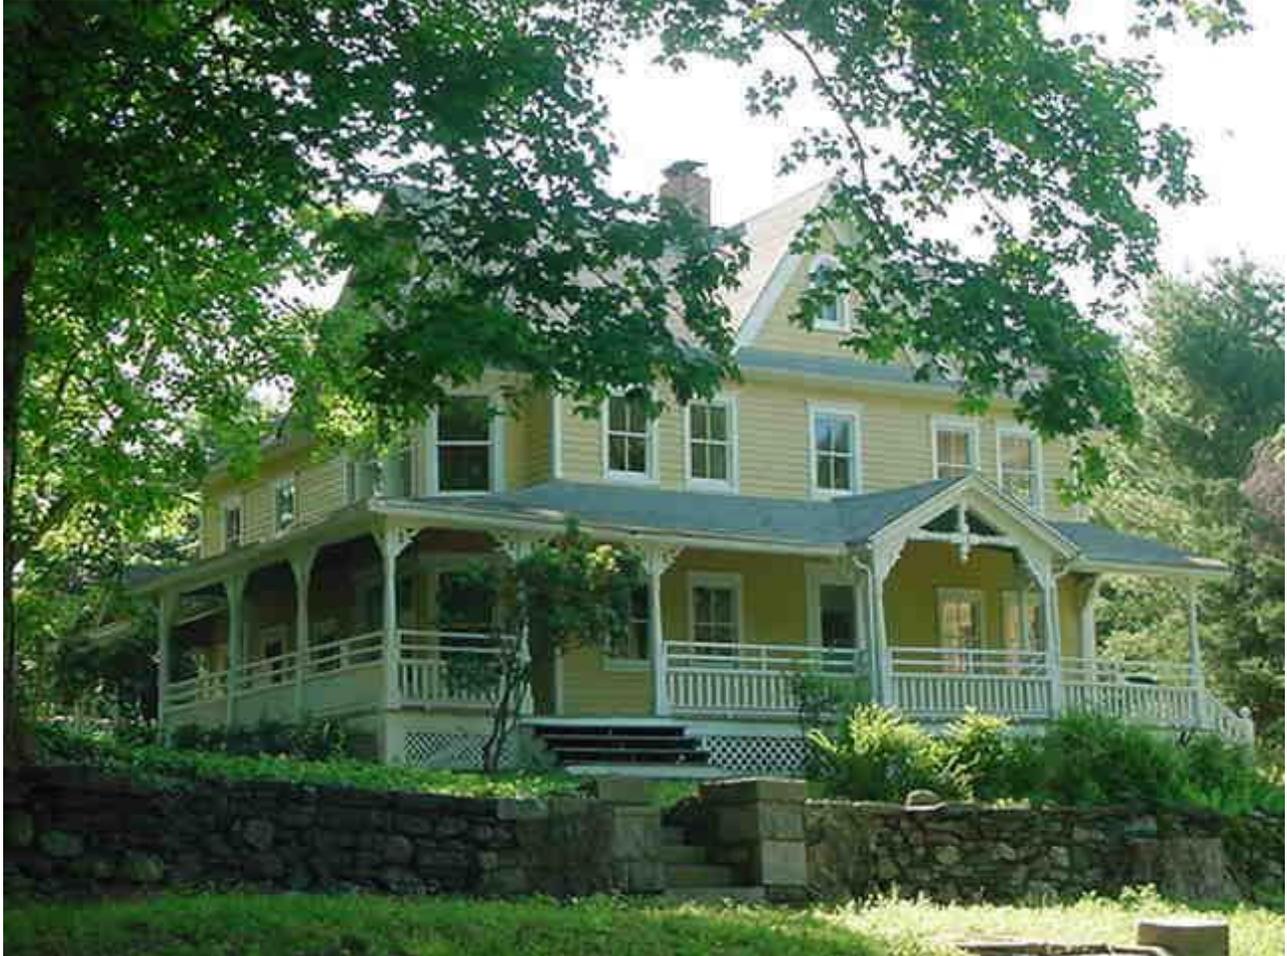
Photograph 275 Hurlbutt Street View

The nucleus of the rambling, picturesque dwelling is a central chimney, five-bay structure built in 1799. It was reworked and enlarged in the picturesque taste during the last quarter of the 19<sup>th</sup> century. The central chimney was removed to accommodate a central hall, but the kitchen fireplace in the back room remains. A central cross gable was added to the façade, and the side elevations were opened up by two-story bay windows with shingled peaks. A wrapping verandah with turned posts, lacey corner brackets, and a plain balustrade was added as was a corresponding porch servicing the rear kitchen ell. The central entrance is defined by a gable with a stick style

fill. Two-over-two windows are used throughout. In addition to the house there is an impressive assemblage of farm-related outbuildings including an ice house, privy, and two bank barns. The property is very well preserved.
